Montezuma Creek - Rapid Watershed Assessment

HUC # 14080203 – San Juan Co., Utah

The intent of this rapid watershed assessment is to gather and display information specific to the Montezuma Creek eight-digit watershed (#14080203) located in San Juan County, Utah. This document will highlight the natural and social resources present in the county, detail some concerns, and be used to aid in resource planning and target conservation assistance needs. This document is dynamic and will be updated as additional information is available through a multi-agency and other interested parties partnership effort. The general observations and summaries are listed first, followed by the specific resource inventories.

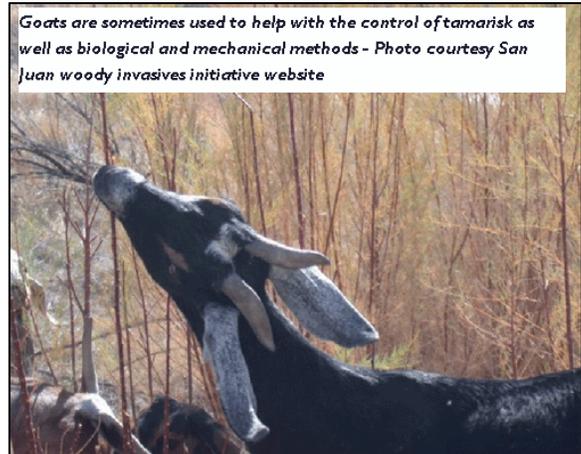
Goats are sometimes used to help with the control of tamarisk as well as biological and mechanical methods - Photo courtesy San Juan woody invasives initiative website

- Invasive plants are a problem for overall management of grazing lands – some progress is being made to address the spread of tamarisk within the watershed (photo right). Some groups have tried to control tamarisk through grazing by goats as shown in the photo, and/or a combination of mechanical and biological methods
- Wildfires are a perennial issue in the watershed - the invasion of cheatgrass following a fire is common if the burn area is not re-seeded soon after the fire

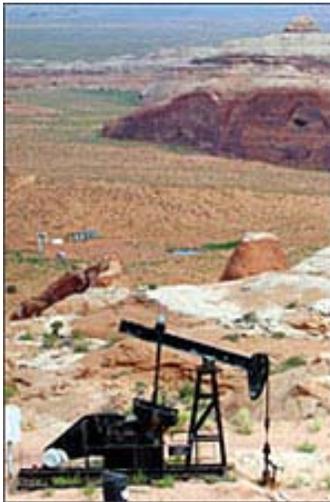
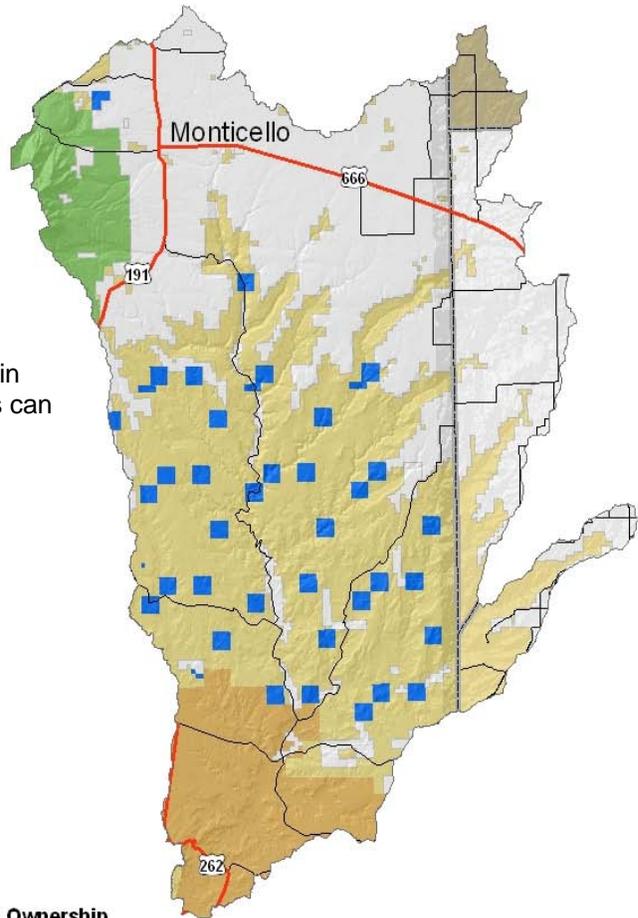
Utah Land Ownership

- State Trust Land - 23,455 acres
- Bureau of Land Management - 213,389 acres
- US Forest Service - 28,434 acres
- Indian Reservation - 59,443 acres
- Private Land - 184,385 acres

Colorado Land Ownership

- Bureau of Land Management - 27,174 acres
- Private Land - 61,501 acres
- State Wildlife Reserve - 9,949 acres

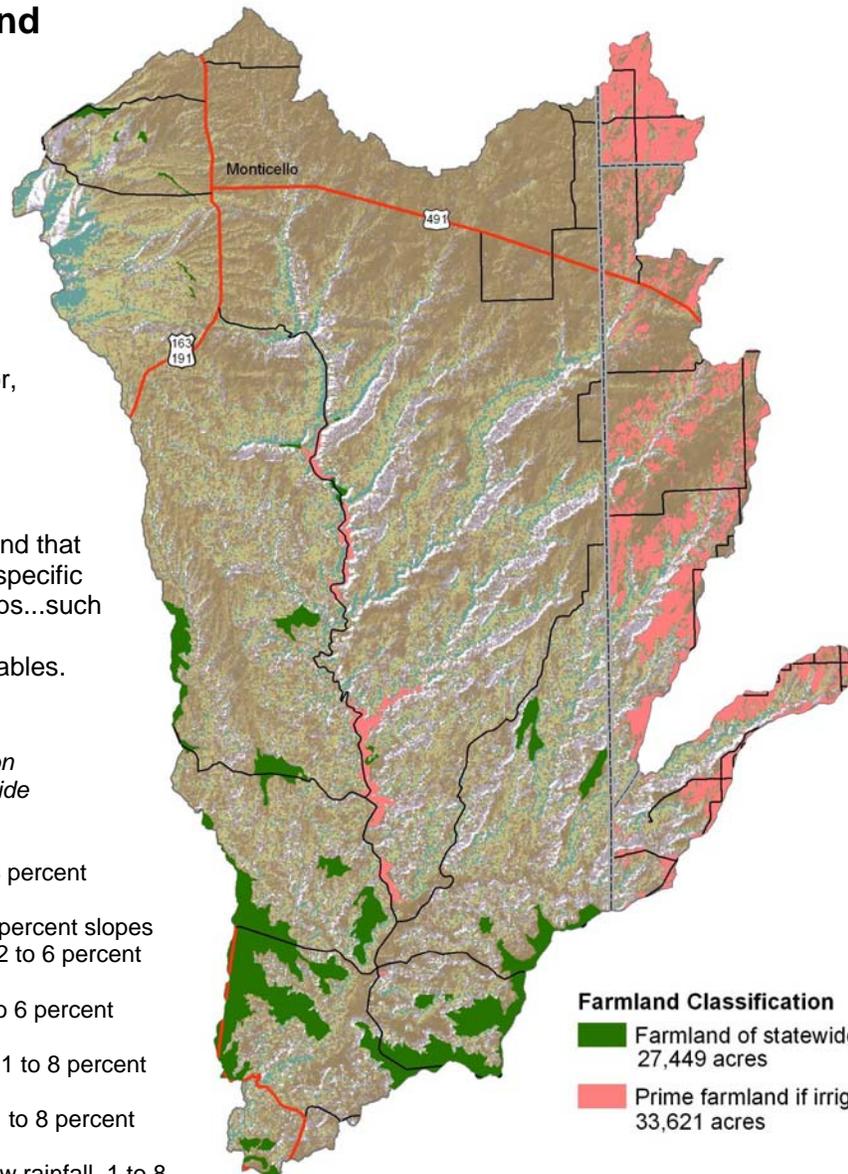
Farmland Classification

- Farmland of statewide importance
27,449 acres
- Prime farmland if irrigated
33,621 acres

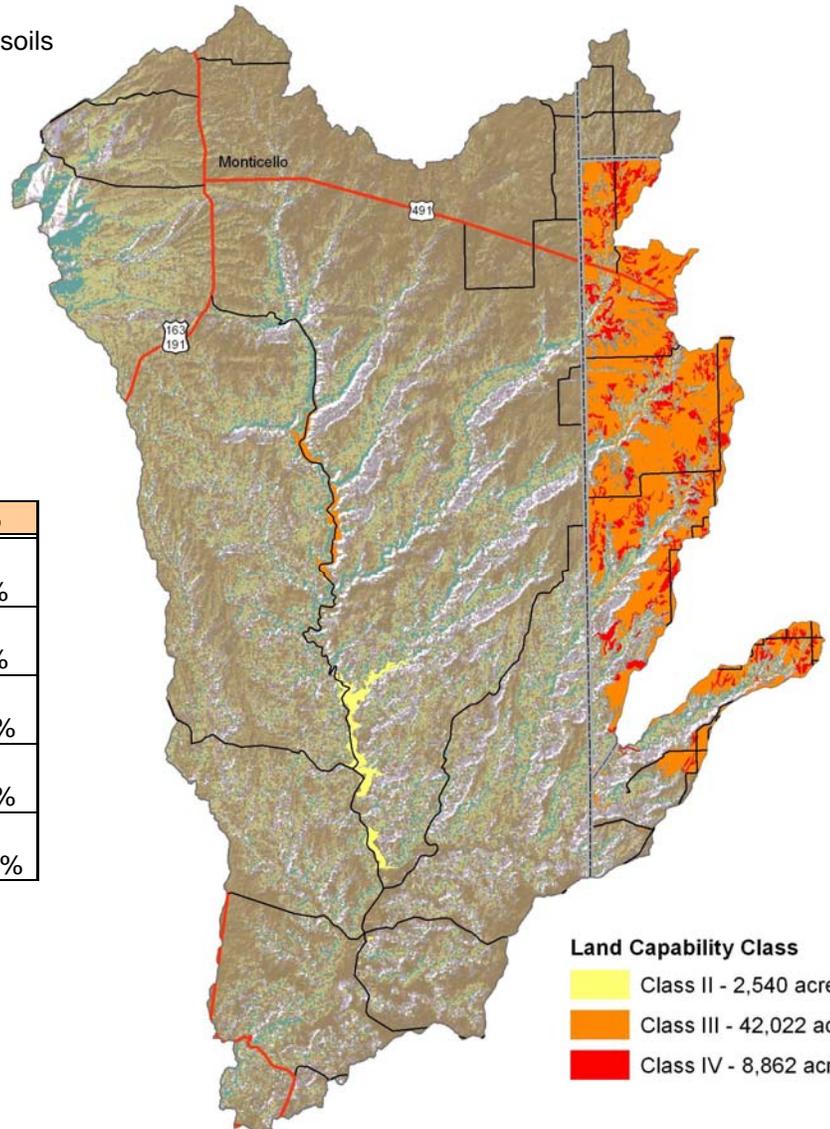
Land Capability Class on Cropland and Pastureland

Capability class is the broadest category in the system. Class codes I to VIII indicate progressively greater limitations and narrower choices for agriculture. The numbers are used to represent both irrigated and nonirrigated land capability.

Acres	%
Land Capability Class (Irrigated Cropland & Pastureland Only)	I - slight limitations	0	0%
	II - moderate limitations	2,540	5%
	III - severe limitations	42,022	79%
	IV - very severe limitations	8,862	17%
	Total Crop & Pasture Lands	53,424	100%

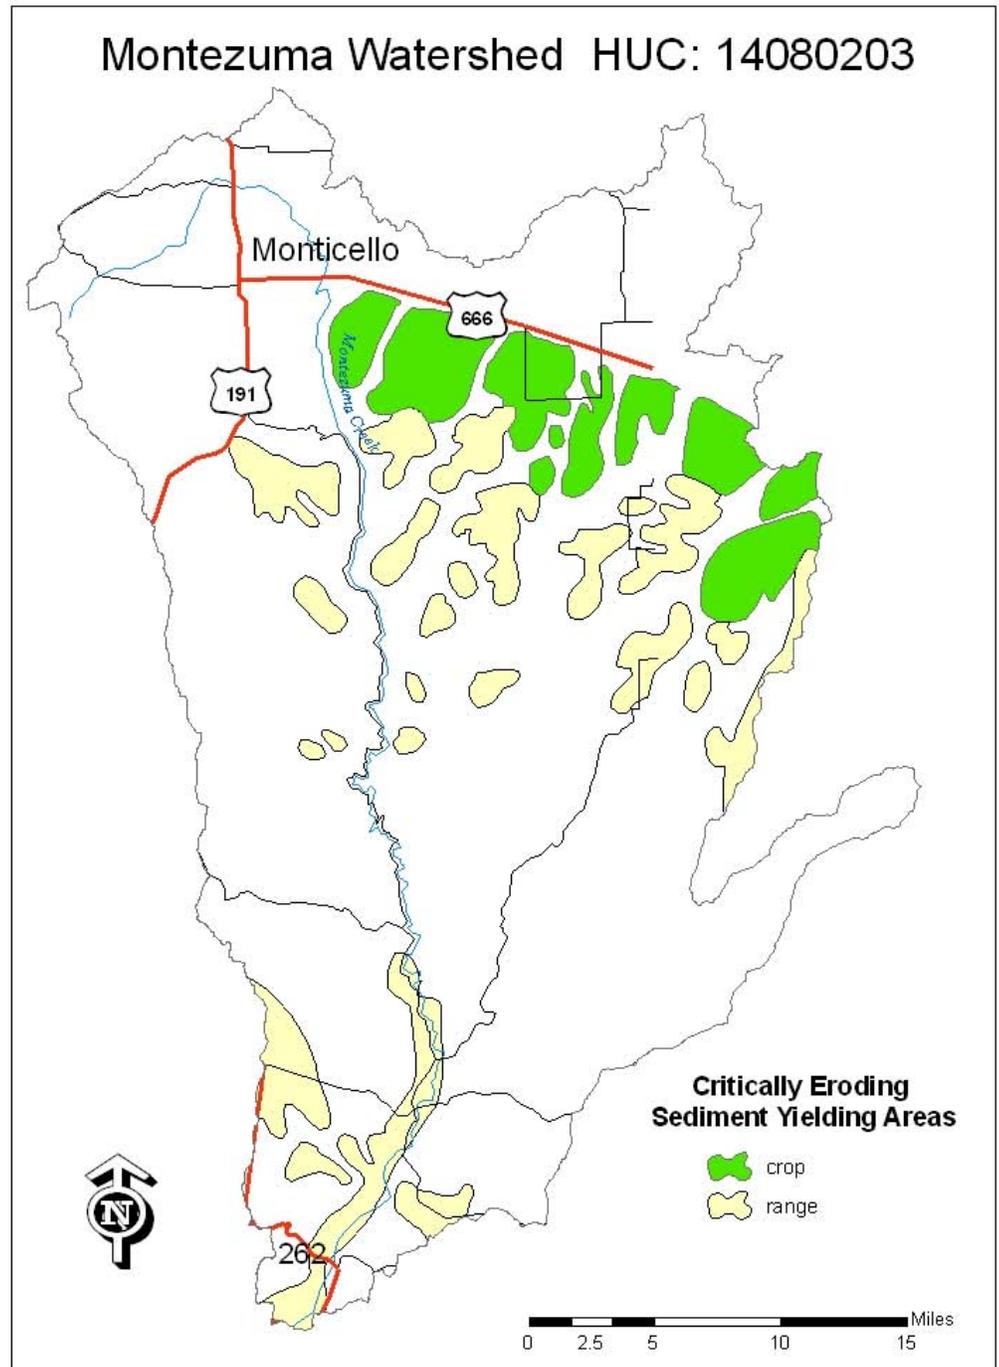
- ❖ Map shows critically eroding areas within the watershed. Severely eroding acreage estimated at 71,800 acres with an average of 2.1 tons per acre sediment yield rate or 149,790 tons and 3,500 tons of salt. A 3 percent salt content was used to derive salt tonnage (NRCS-BLM, Feb. 1988). These rates may have changed since then due to conservation practices implemented in the area since then.

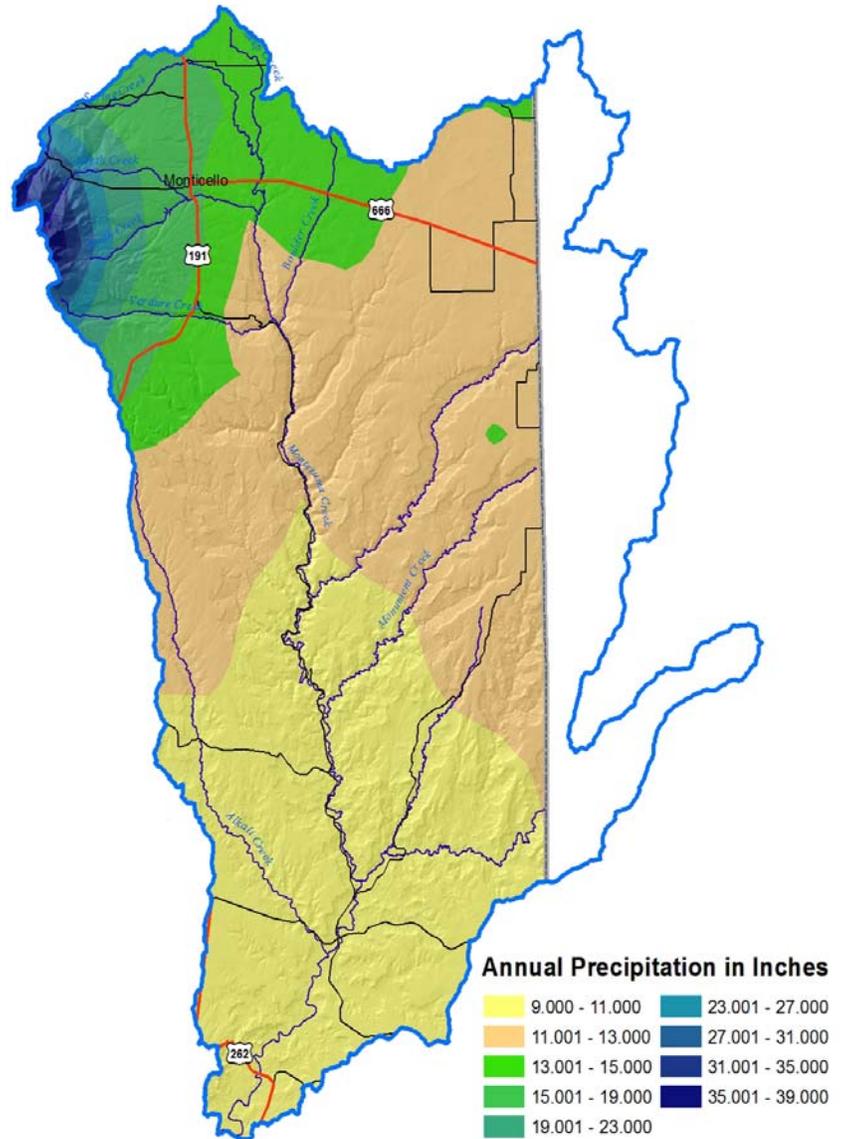
Precipitation and Streams

ACRES	ACRE-FEET
Irrigated Adjudicated Water Rights	Surface	8930.00	35720.00
	Well		
	Total Irrigated Adjudicated Water Rights	8930.00	35720.00
Stream Flow Data	USGS 09379500 San Juan River Near Bluff, UT	Total Avg. Yield	11,075
		May-Sept Yield	15,555
Stream Data		MILES	PERCENT
	Total Miles - Major (100K Hydro GIS Layer)	2140.00	n/a
	303d (DEQ Water Quality Limited Streams)	0.00	0%
