# **Silver Lake Flat Dam Rehabilitation Supplemental Watershed Plan - Environmental Assessment**

# Public Scoping Meeting Agenda

# Silver Lake Flat Dam Rehabilitation

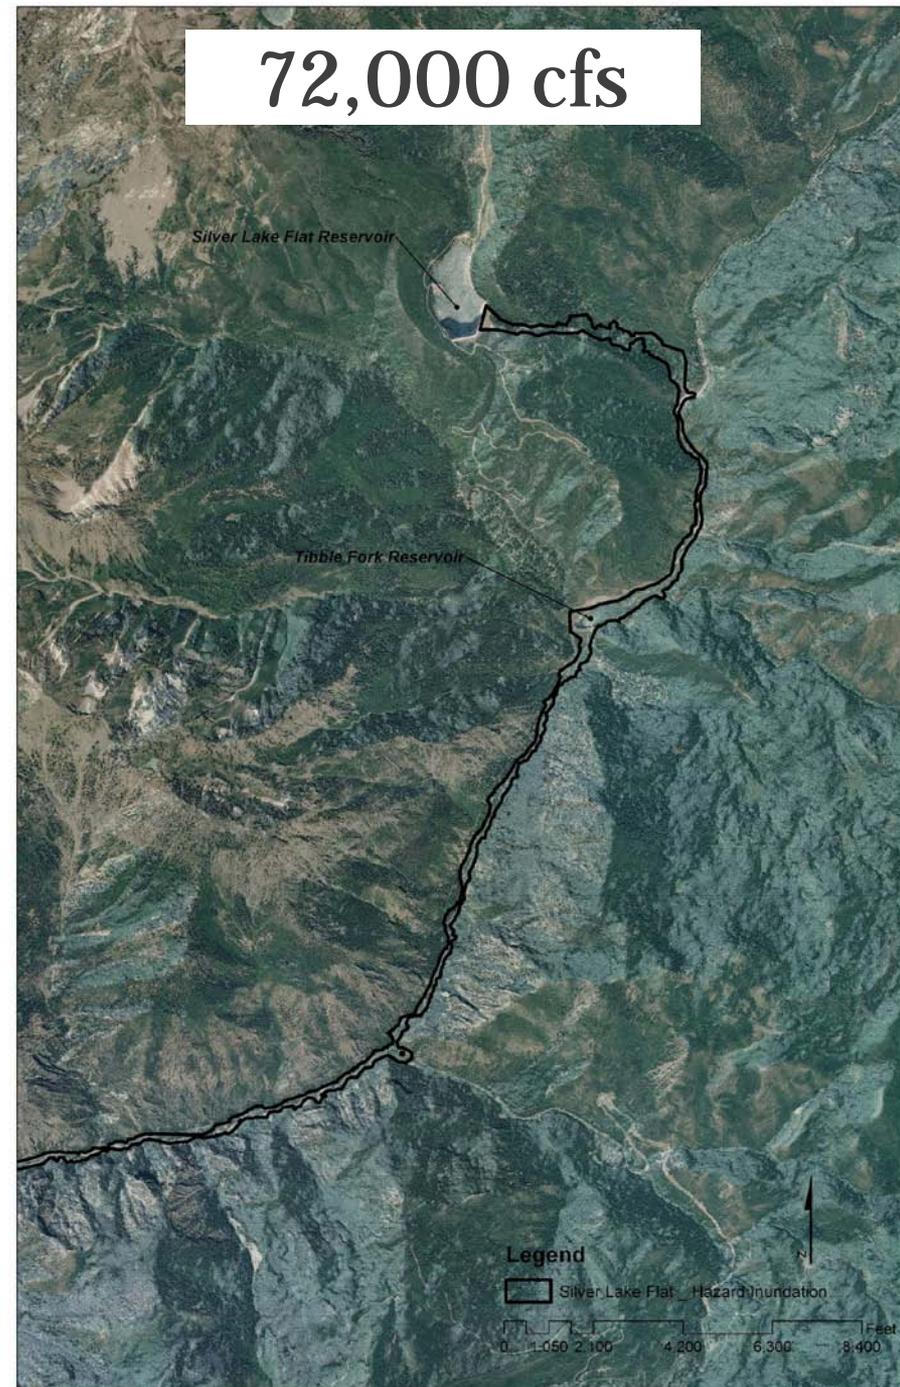
# Dam Breach Map 1

- Breach in Left Abutment

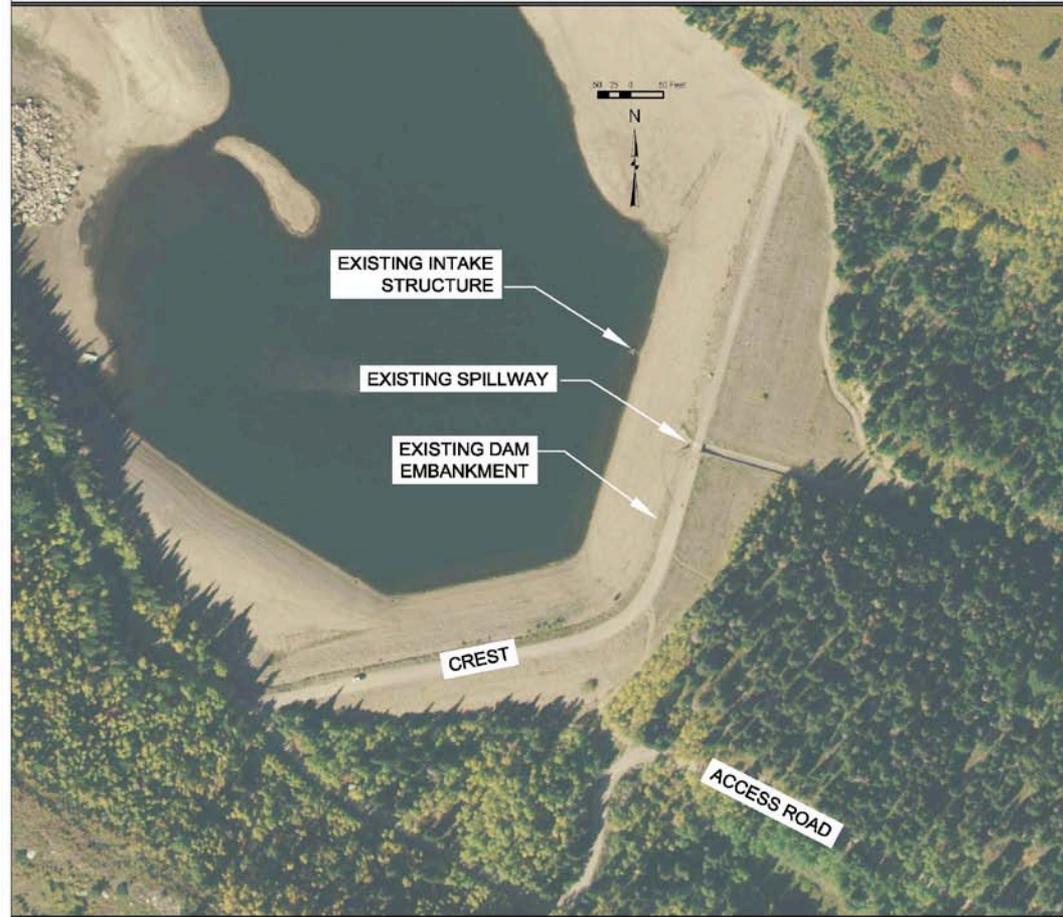
## Silver Lake Flat Dam Existing Conditions of Dam

CREST ELEV. 7534'  
EXISTING SPILLWAY ELEV. 7525'  
CURRENT STORAGE = 1033 ac ft

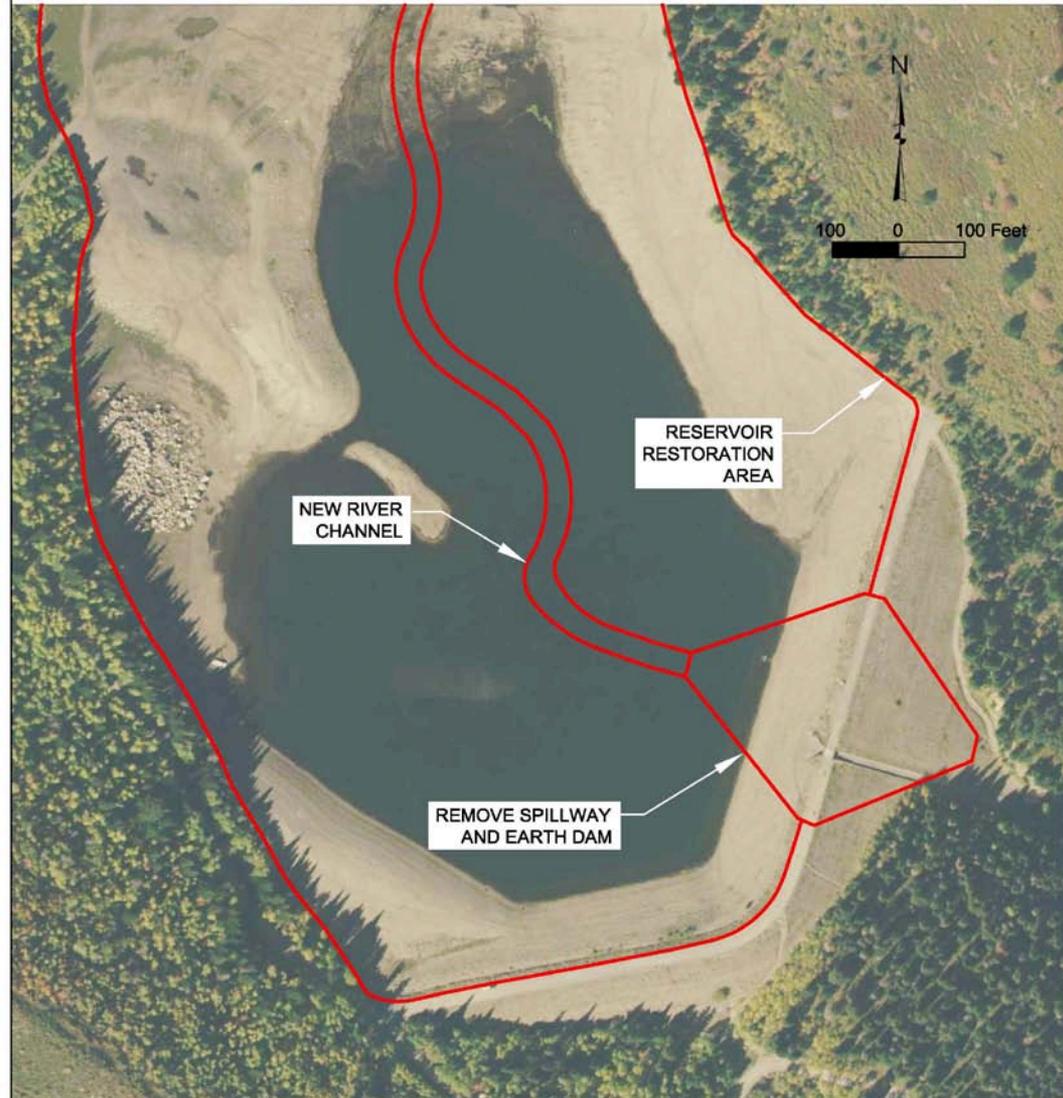
## Conceptual Silver Lake Flat Dam Decommissioning

- Create Breach in Dam
  - Unobstructed Natural Flow
  - Create River Channel
  - Restore Pool Area

~125,000 Cubic Yards

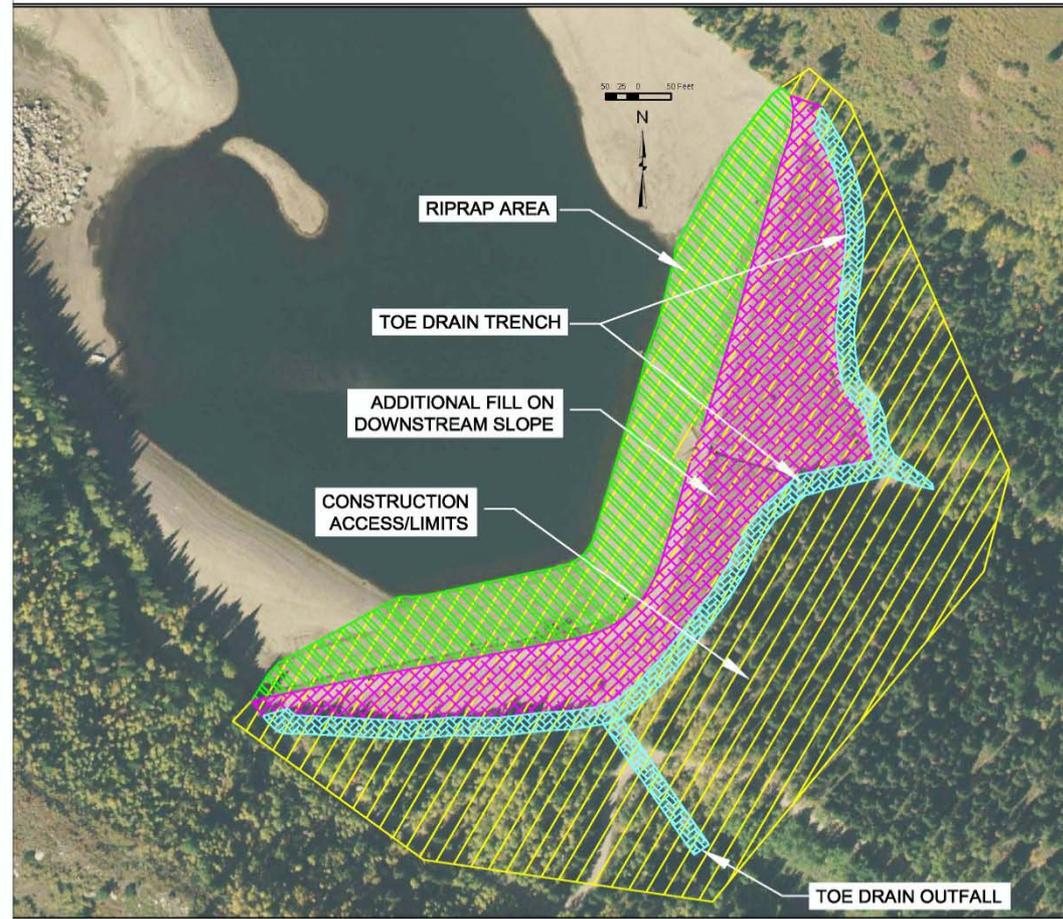
## Silver Lake Flat Dam Work Plan

- Riprap on the upstream face
- Fill on the downstream face
- Install toe drain
- Upgrade the existing spillway capacity
- Replace outlet gate

NEW CREST = 7535.5'  
NEW SPILLWAY = 7526.5'  
NEW STORAGE = 1100.7 ac ft

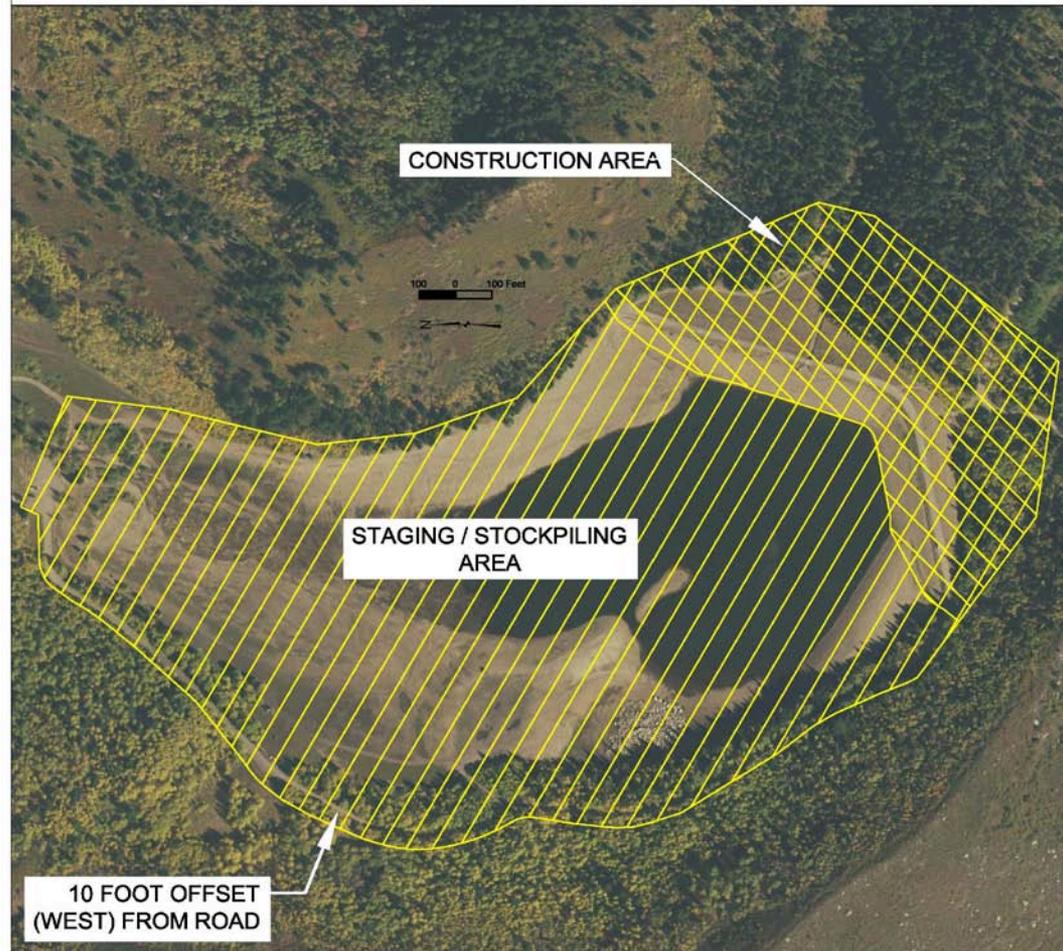
## Silver Lake Flat Dam Staging Area

- Construction Area
- Staging/Stockpiling Area

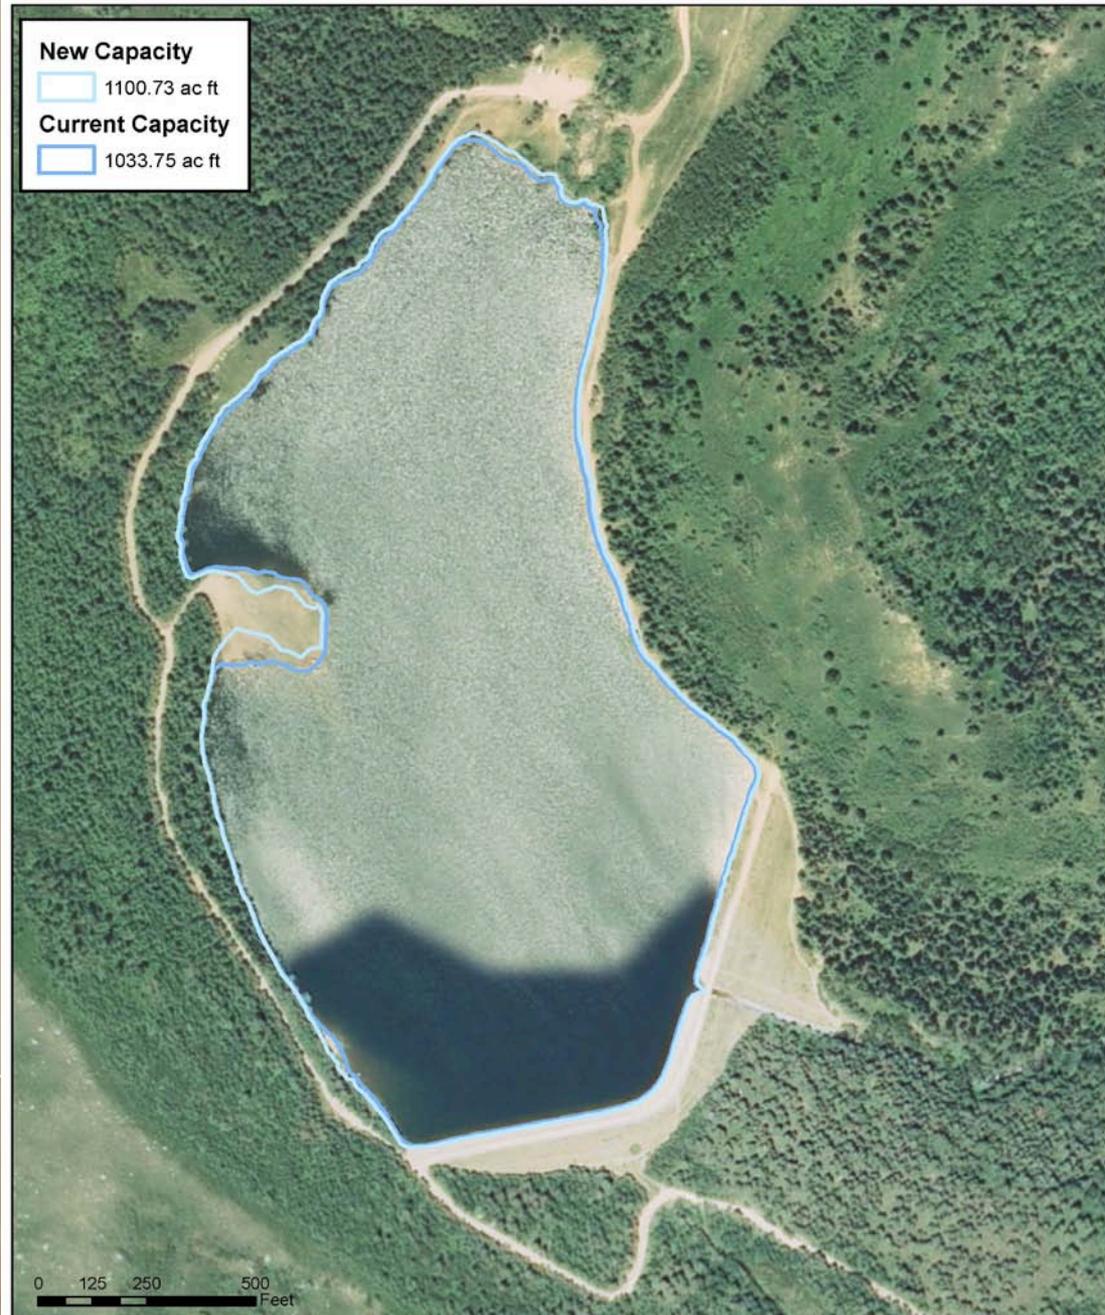
## Silver Lake Flat Raise 1.5 Feet

- Currently 7.5 feet of freeboard to spillway crest
- Raise dam fill and spillway crest 1.5 feet
- Increase spillway capacity approx. 4x

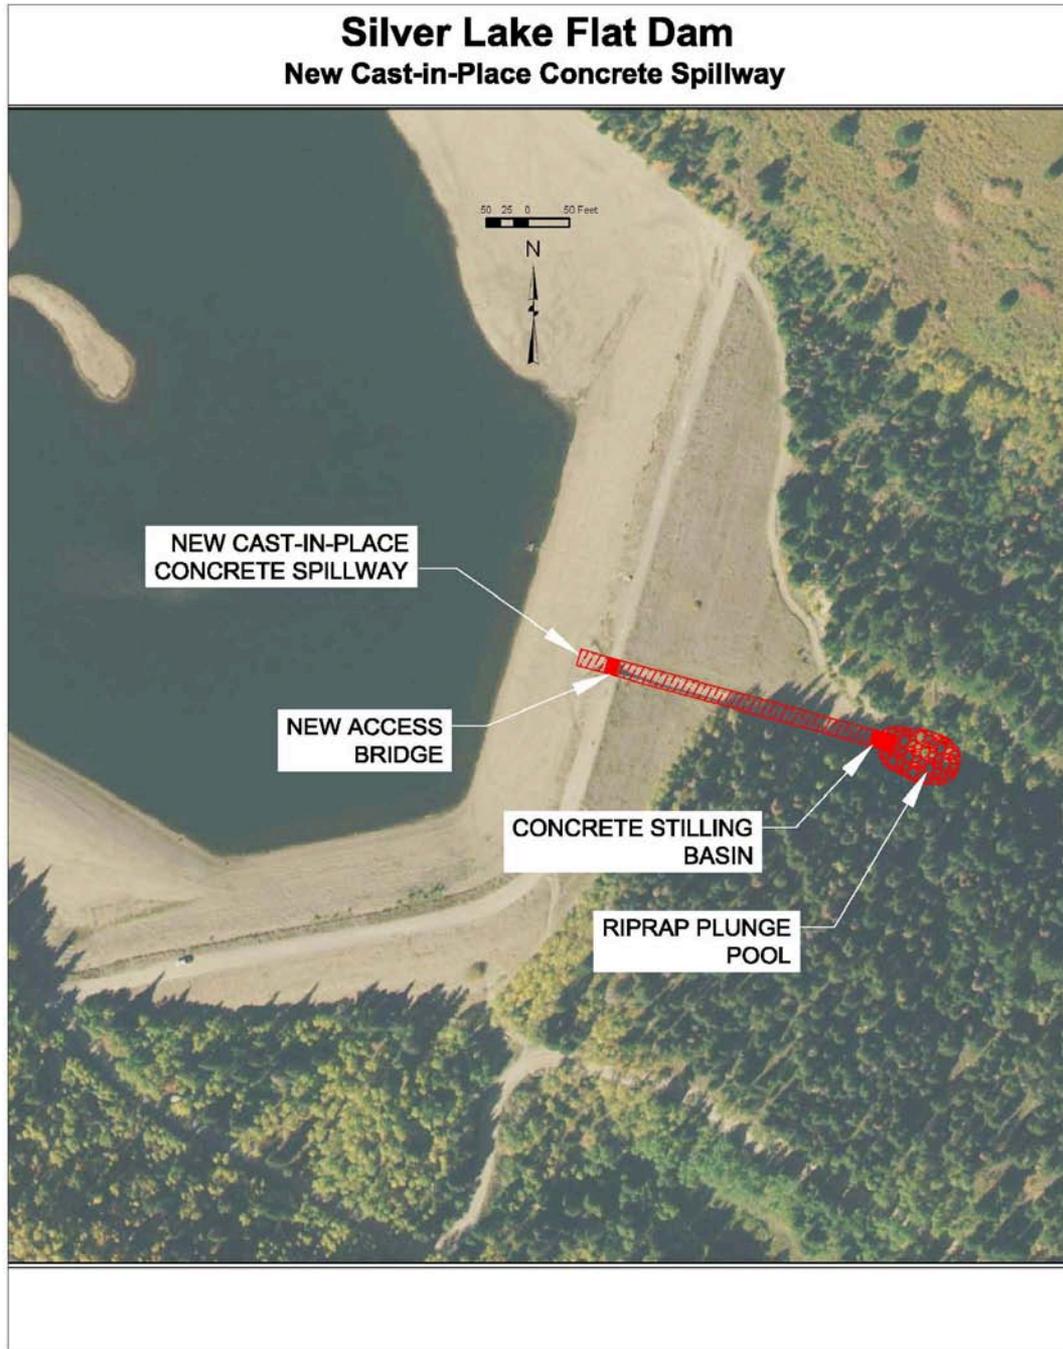
## Replace Spillway

- Demolish existing spillway
- Install spillway in same location

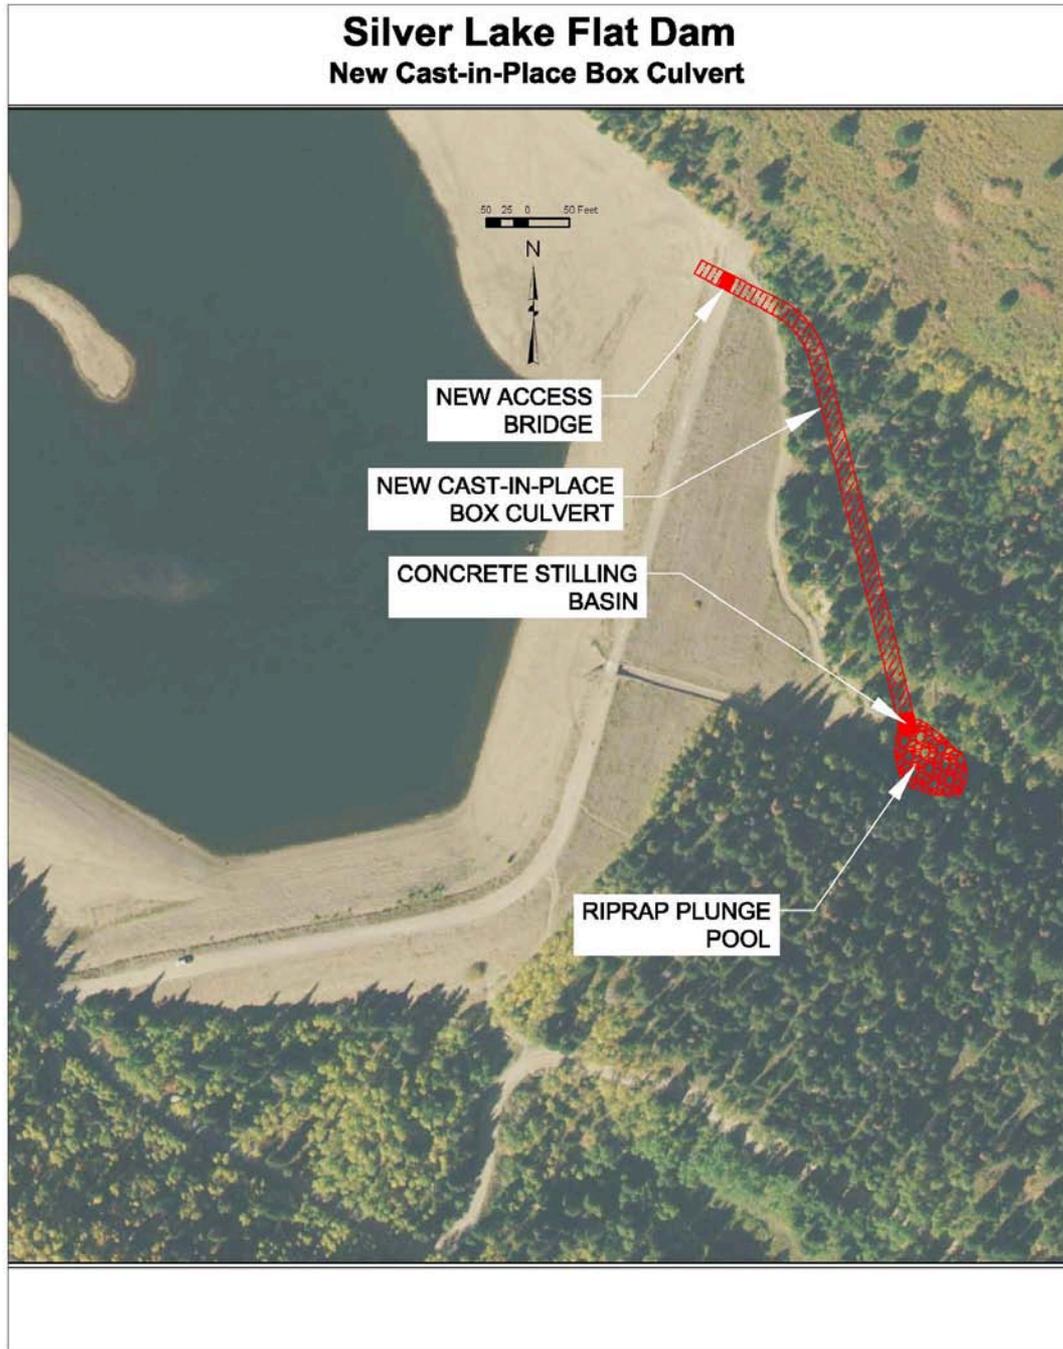
# Dam Rehab New Spillway

- Demolish existing spillway and fill
- Install new spillway on left abutment

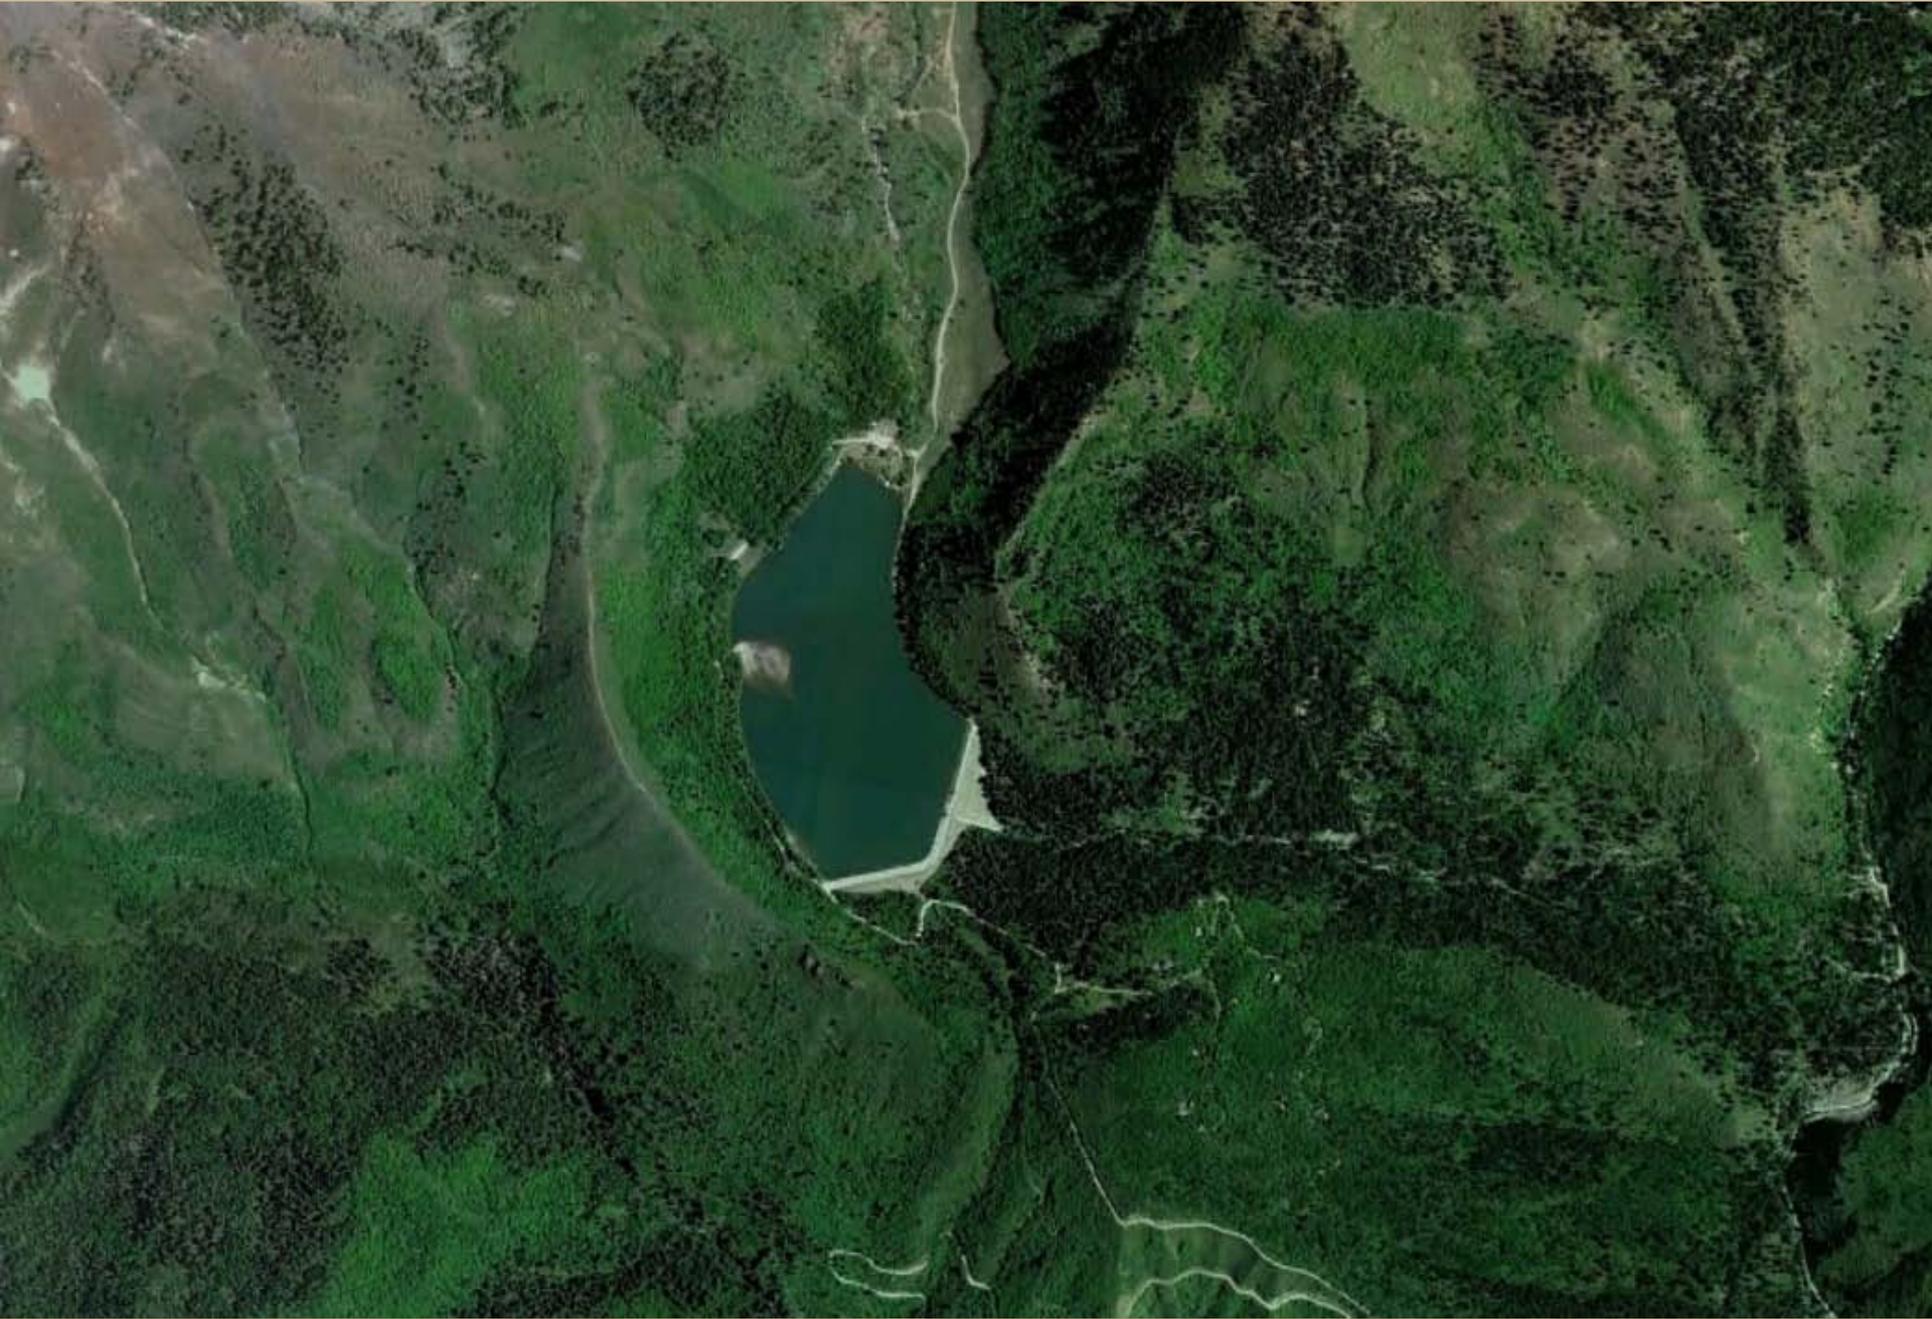
EXISTING INTAKE  
STRUCTURE

EXISTING SPILLWAY

EXISTING DAM  
EMBANKMENT

CREST

ACCESS ROAD
