Garden City Summit

The Garden City Summit snow course is located near the watershed divide of the Logan River and Bear Lake at an elevation of 7600 feet msl. The course is in a small drainage physically cut off by highway 89 about 200 yards to the north. This course has been dramatically altered by vegetation change. At one time it was along a narrow road directly in the bottom of a small drainage with primarily aspens as the dominant vegetation. It is now primarily dense conifer cover with the trees close enough that the melt rings from long wave radiation off the trees as well as the interception factor are influencing sample points.

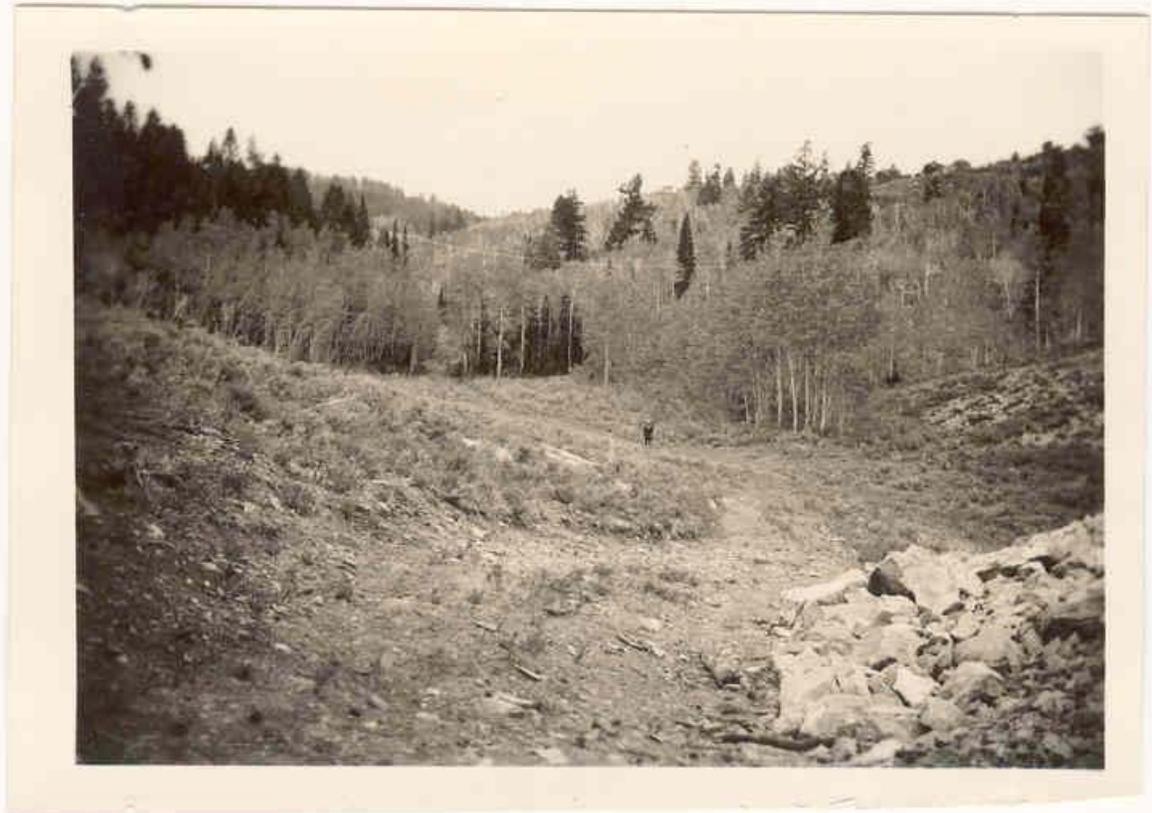
This photo from 1936 is looking south southwest up the drainage. To the bottom right is the fill base or beginning of highway 89 from Logan to Bear Lake. The course begins about halfway from the individual in the photo to the aspens in the upper left. Notice the prevalence of aspens in the photo with some individual conifers on the upper right and one tongue of conifers in the upper left.

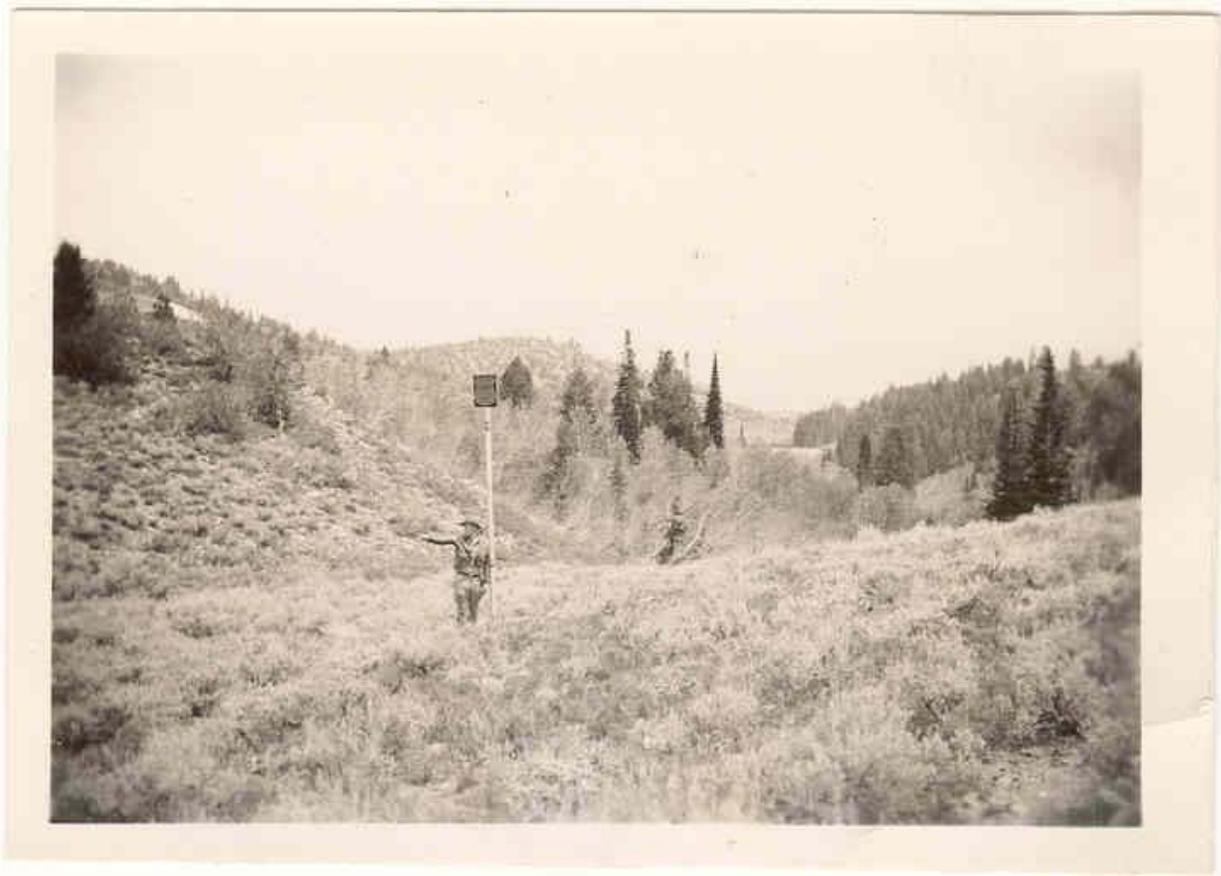
This photo take from the top of the course looking north northeast also shows the aspens in the bottom of the canyon on both sides and the single tongue of conifer coming from the east (right).

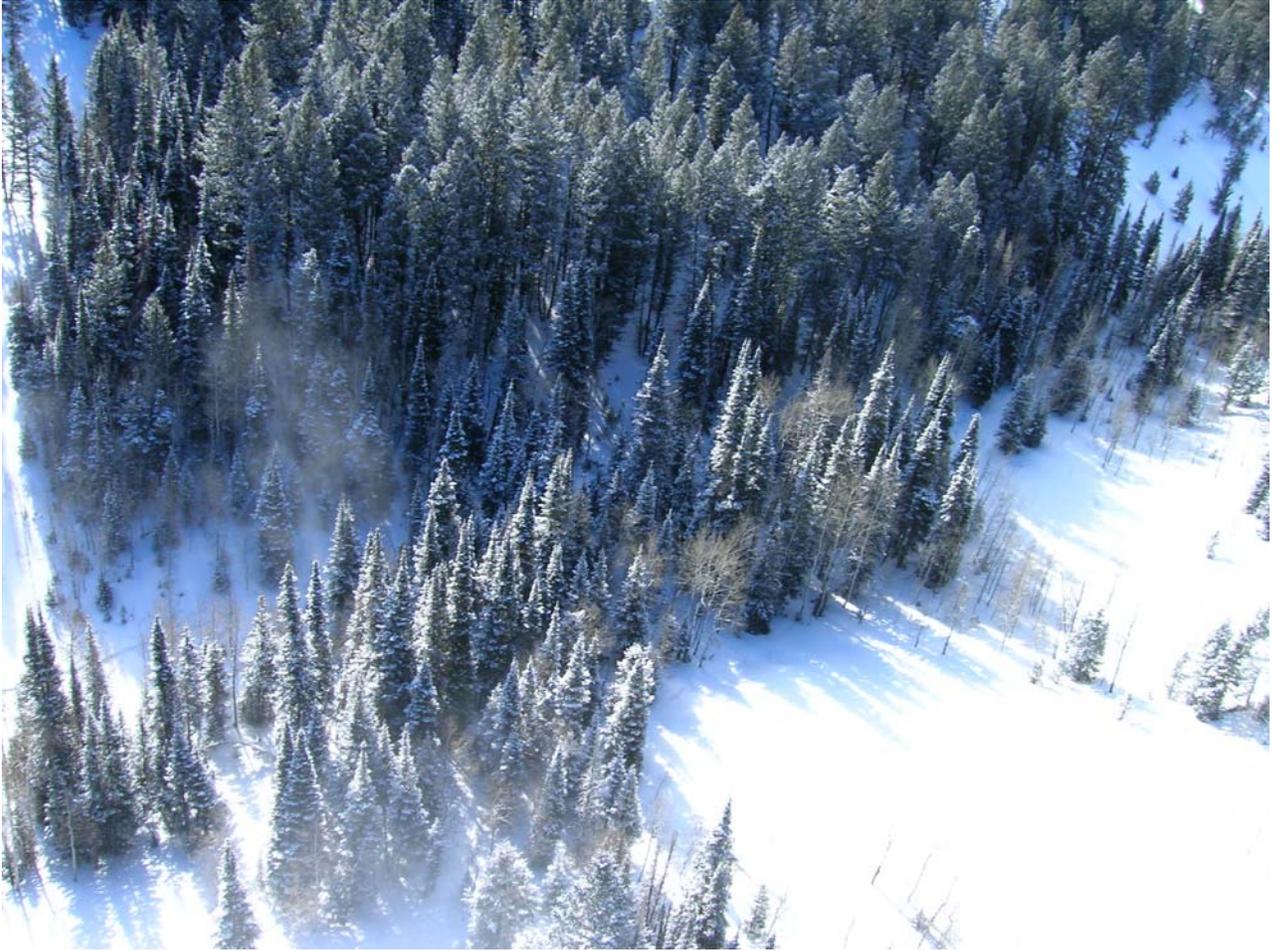
In this aerial photo from the March 2007 survey you can see that the once predominant aspen cover has been completely replaced by dense conifer cover. The course runs up the center of the drainage and one can see the snowshoe tracks along the bottom left of the photo. Accumulation and ablation characteristics have been altered by this change in vegetation.

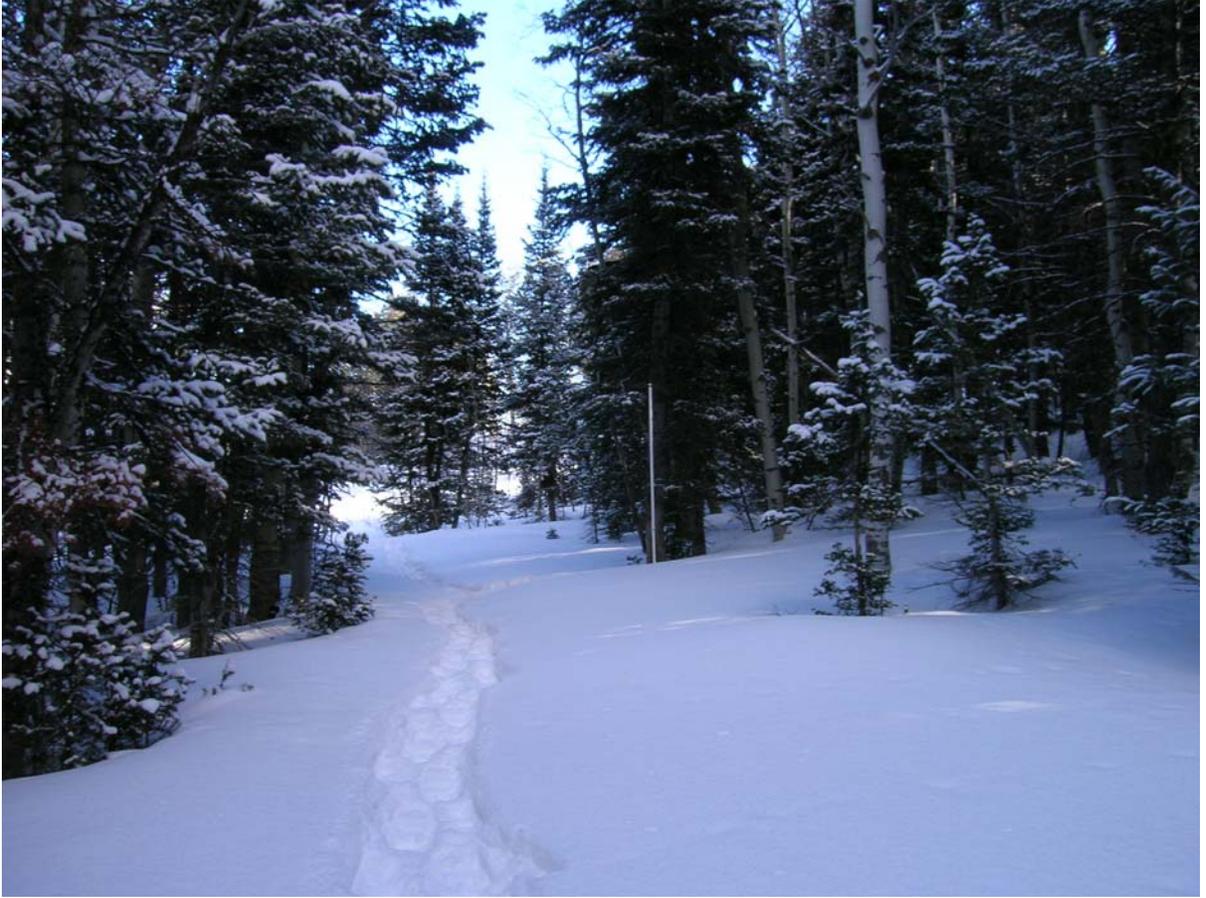
Sample number 1 looking north at the beginning of the course.

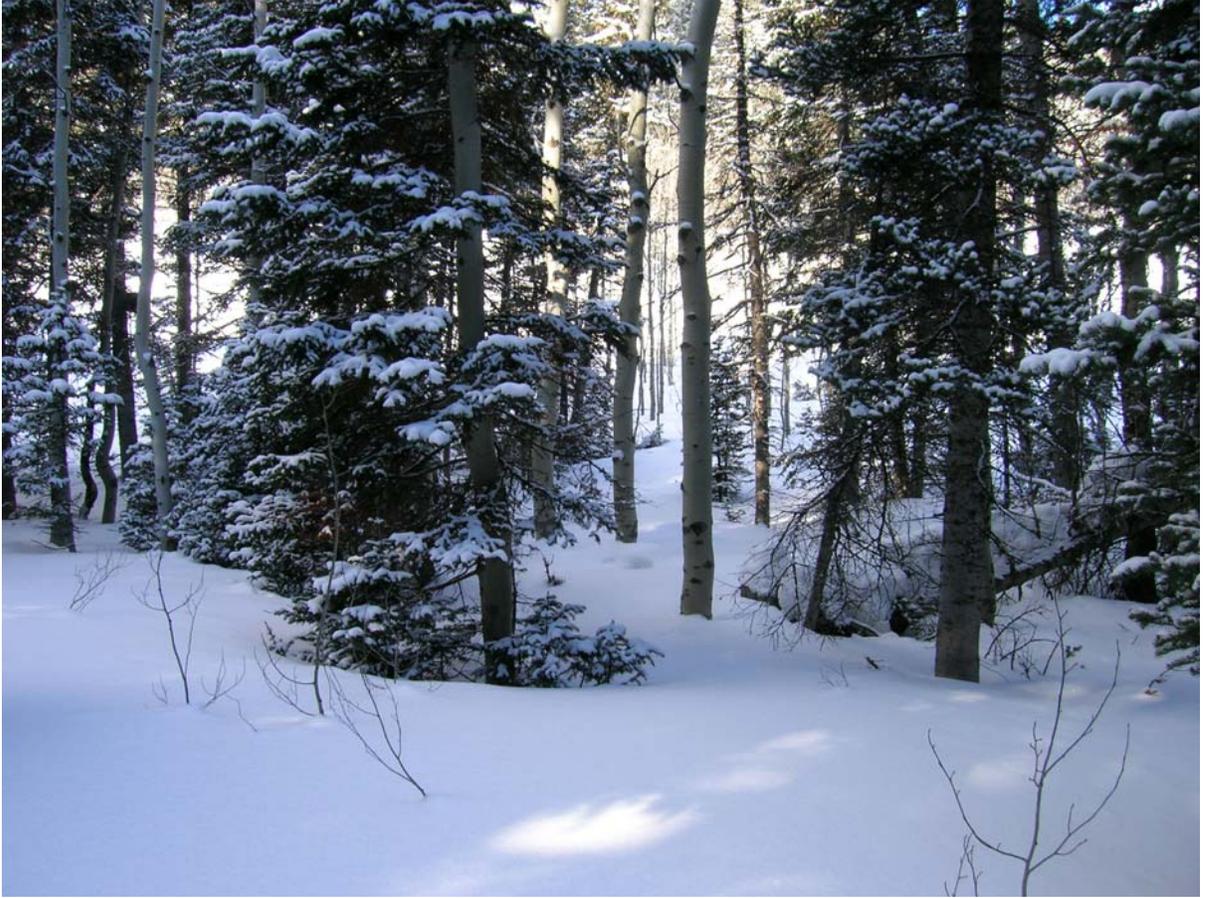
Looking northwest west through the least dense part of the conifers.

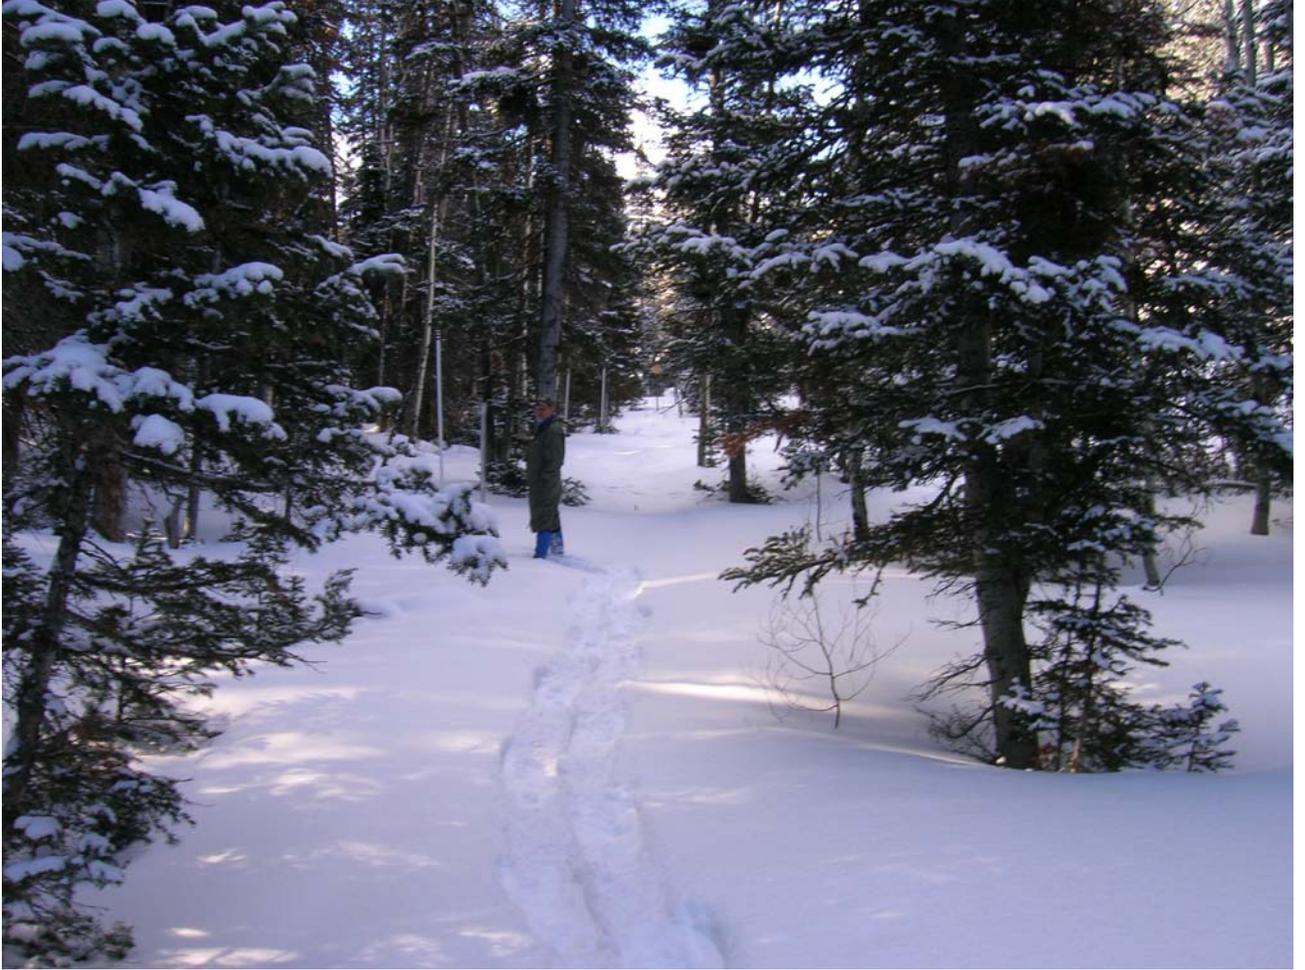
Looking south southwest along the course, notice the close proximity of the conifers to the sample markers.

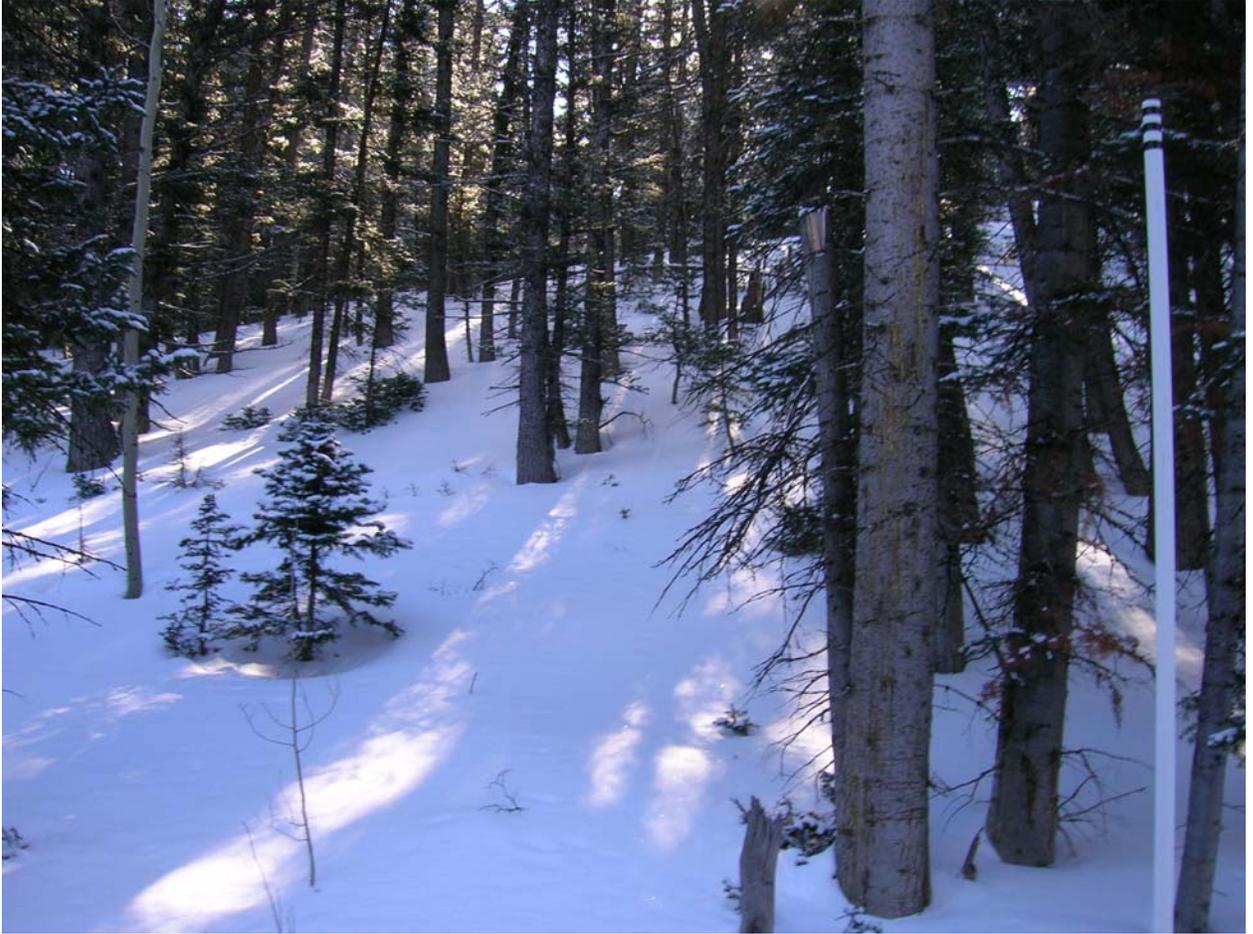
Looking up the hill to the southeast in the more dense portion of the conifers.

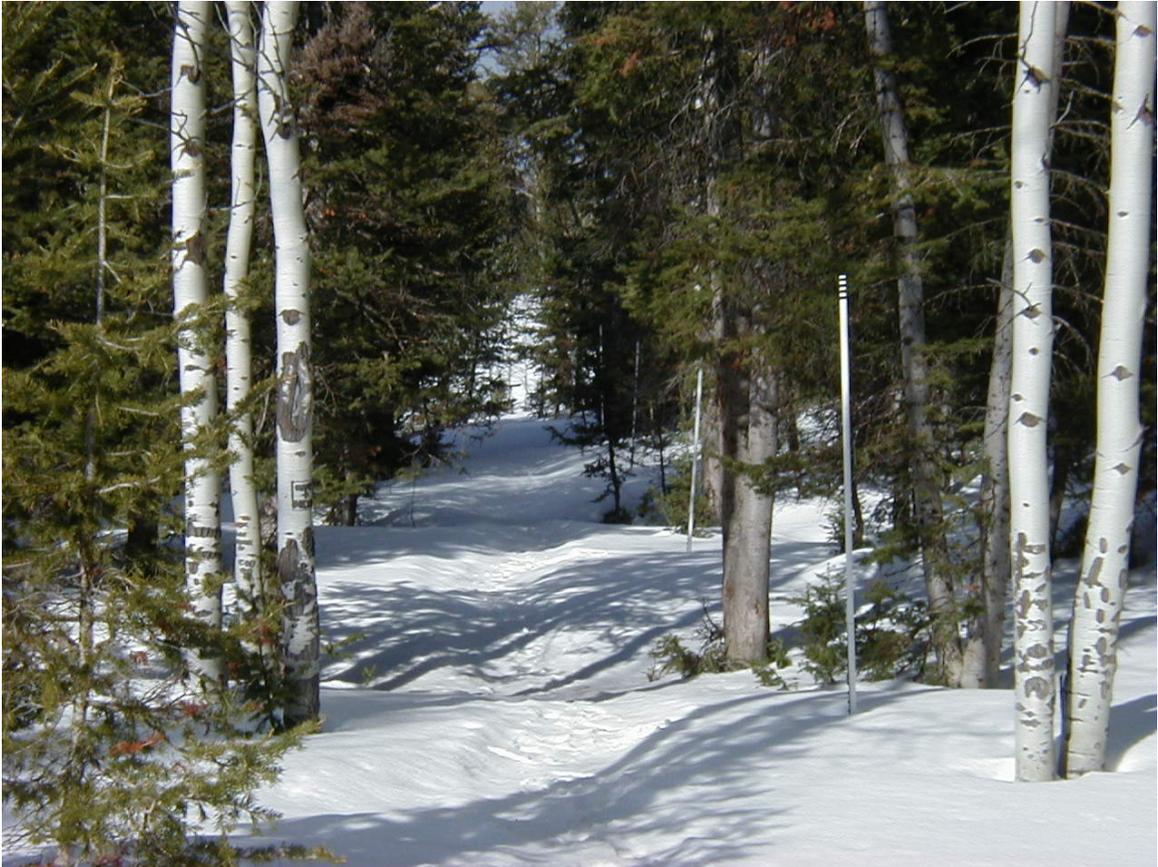
This photo shows clear impacts of the current conifer overstory impacts on the course. Note the melt rings around various trees and the undulating snow surface where deposition has been altered by conifer crowns.

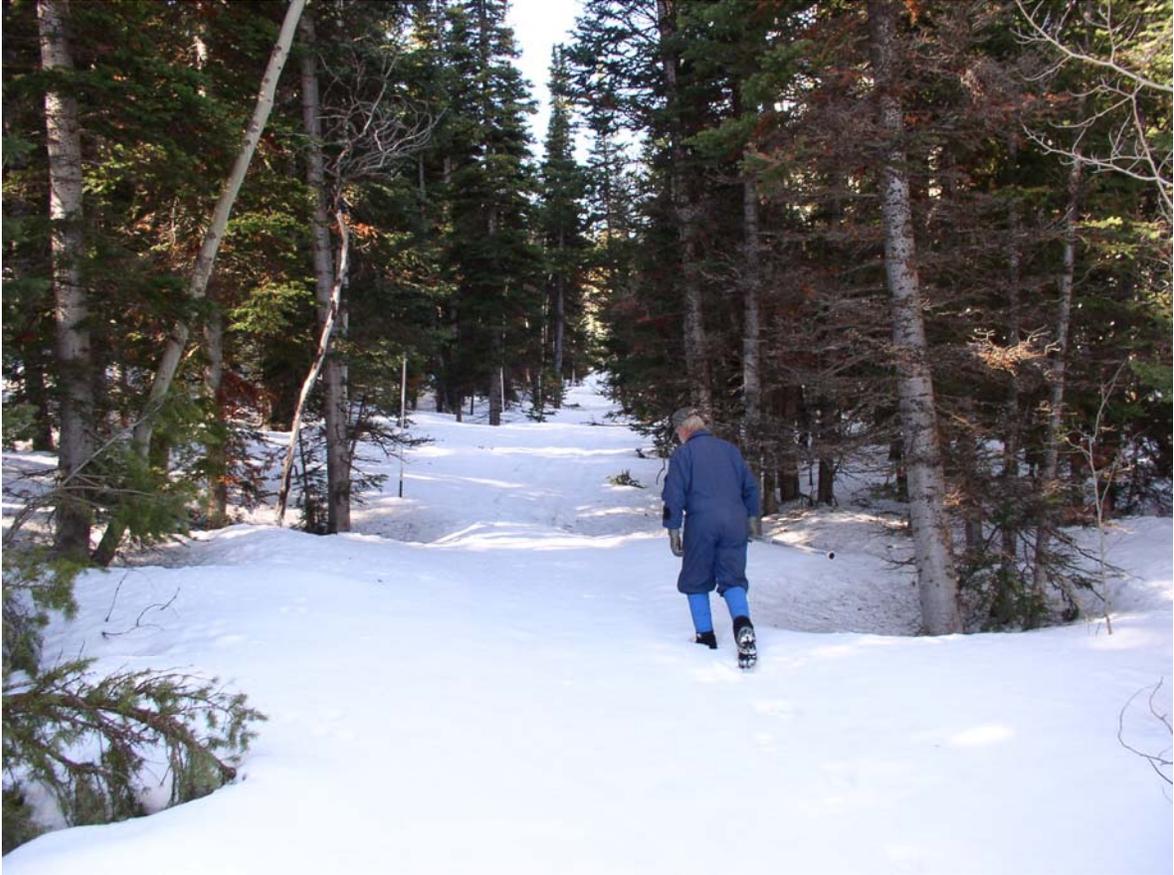
Melt rings near and at sample points. At this end of the course in the early 2000 time frame, several large conifers that were physically impacting sample sites were removed. It is likely that these sample points will be accumulating more snow currently than in previous records.

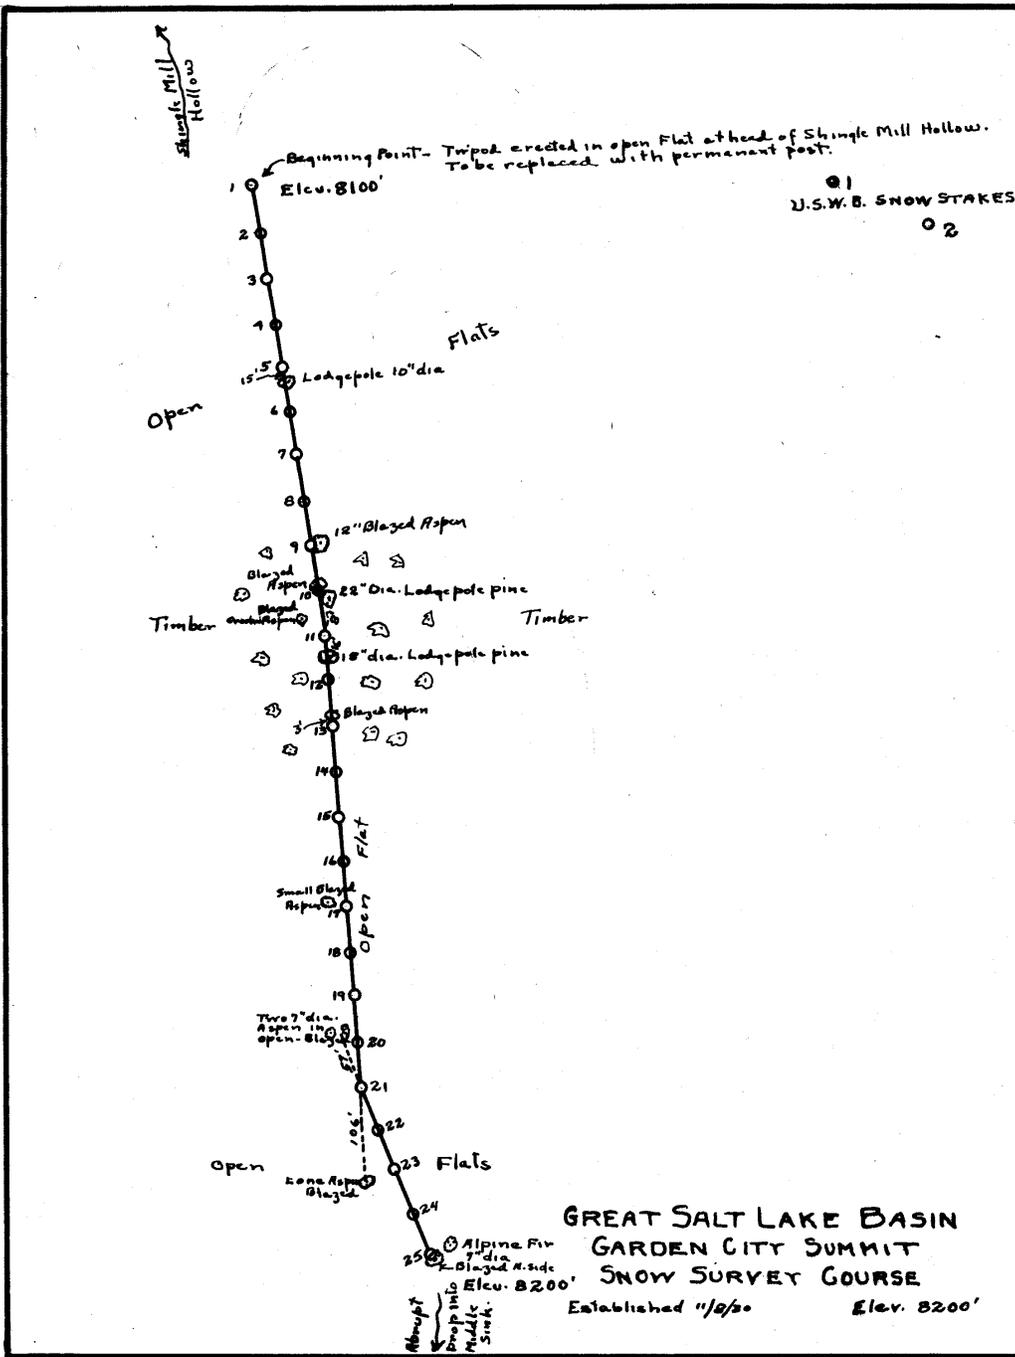
Original Garden City Summit snow course Map.

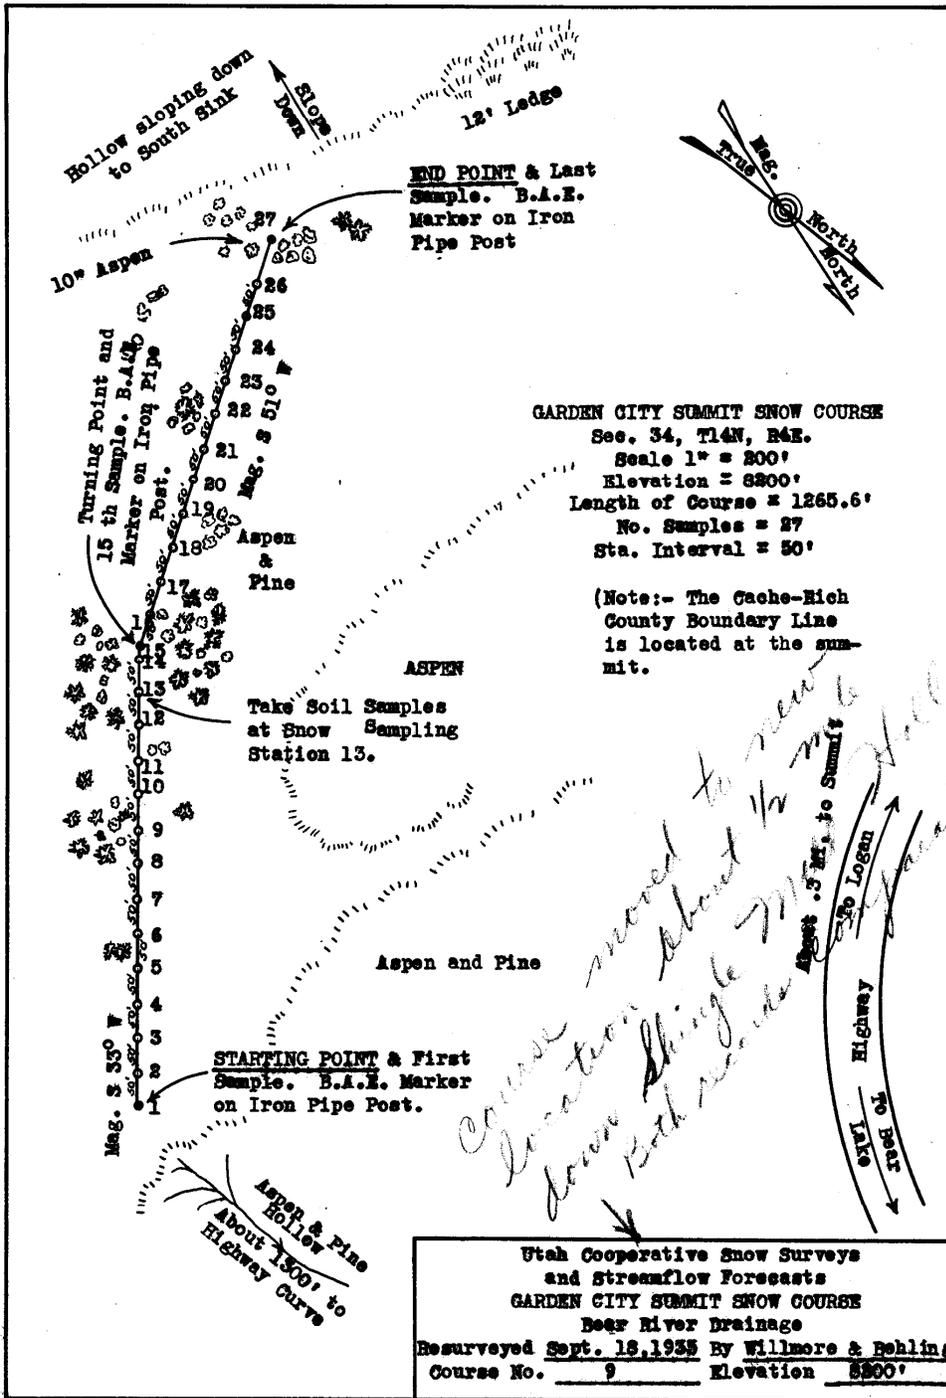
Course moved closer to highway.

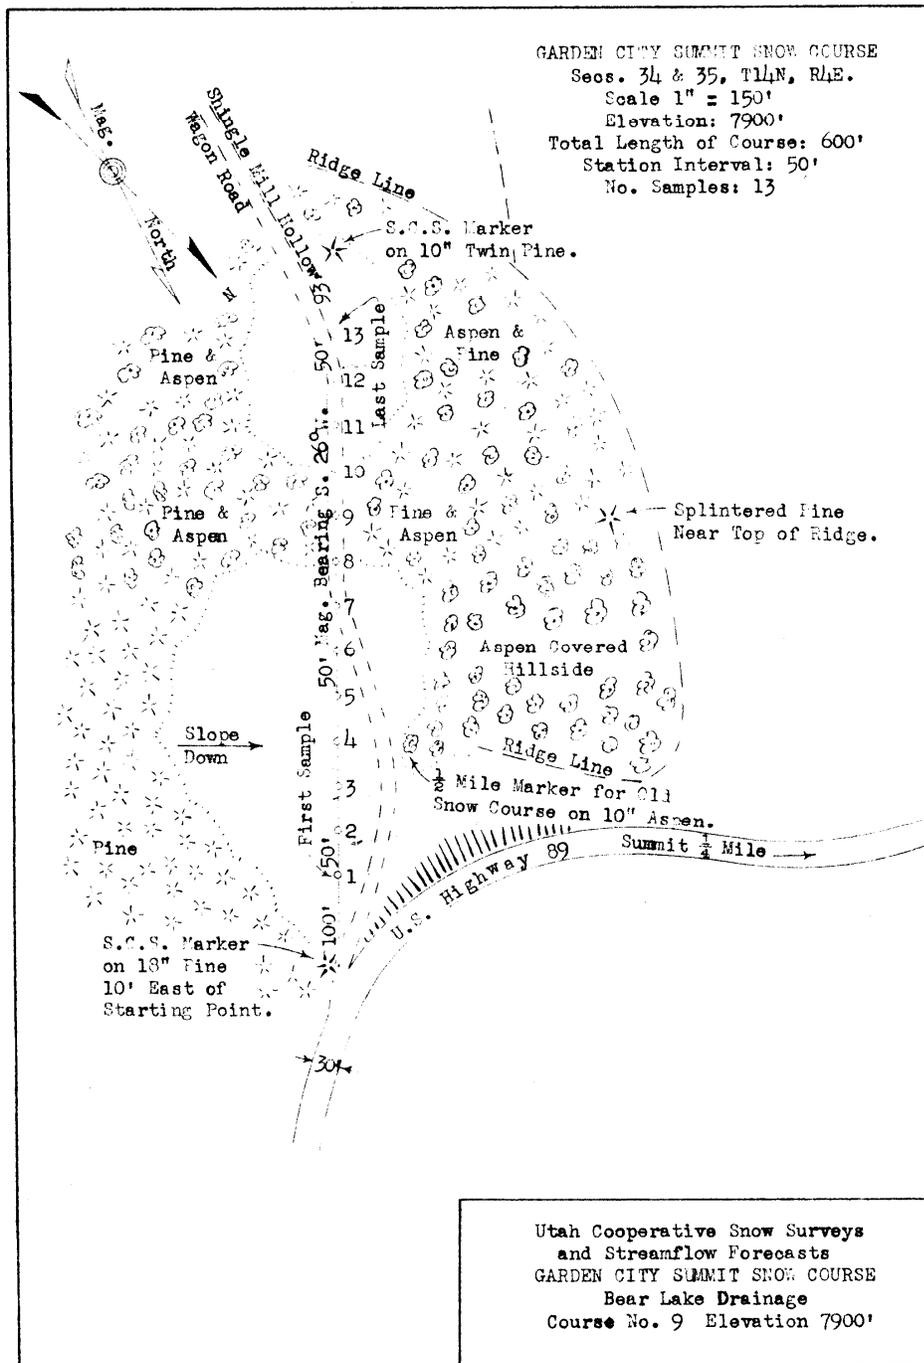
New course with 13 sample points. Note the open meadow conditions from samples 1 to 8 and 11 to 13.

Course shortened to 5 samples 12/74

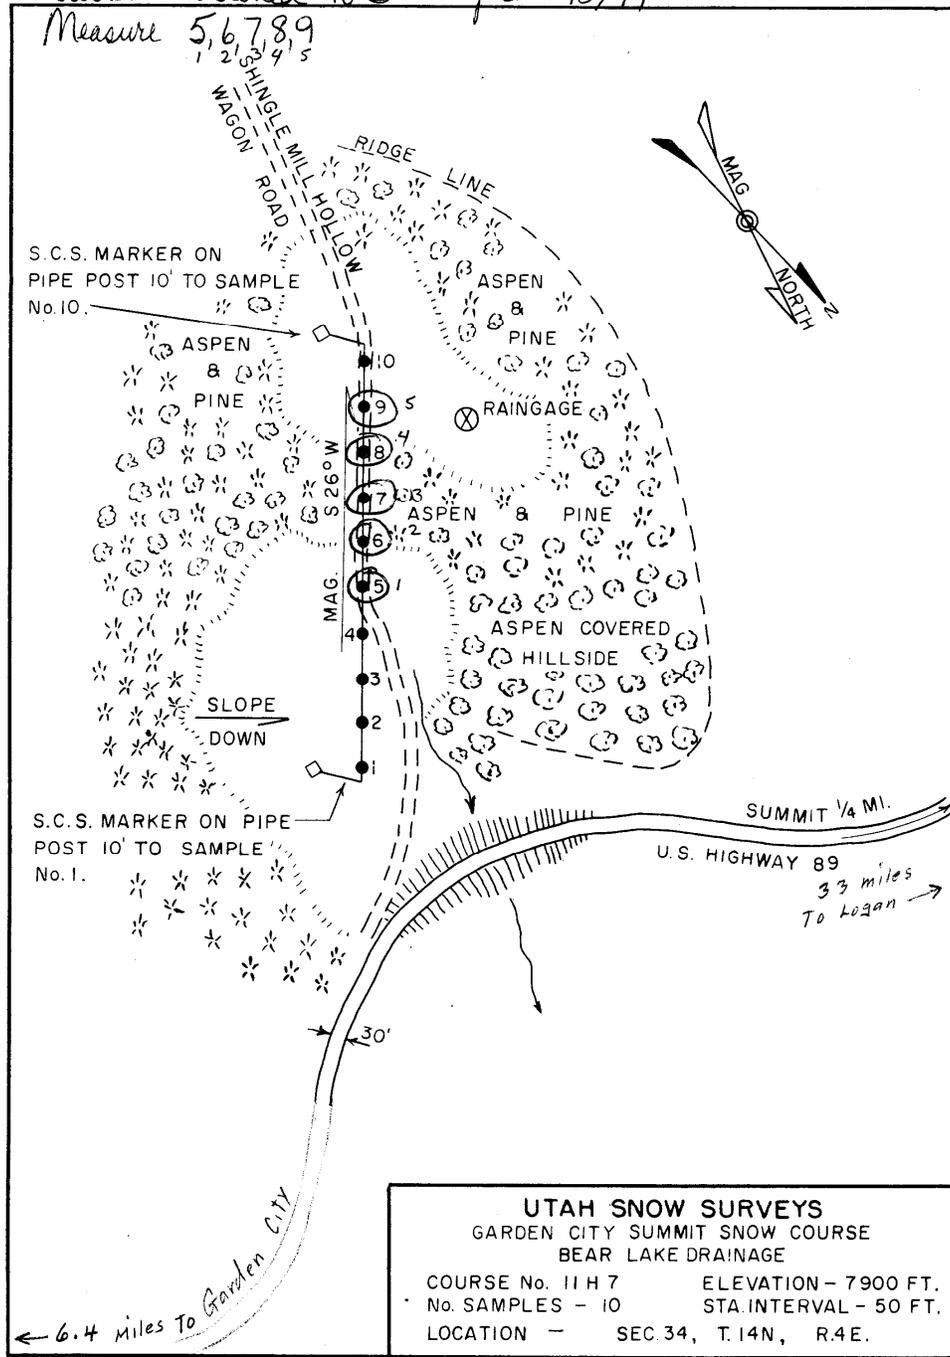
Current course configuration with 5 sample points as of 1974. somewhere between this map and the previous map, the course was shortened from 13 points to ten.

When a snow course was shortened, the original points continue to be measured although renumbered, thus points 1,2,3,4 and 5 may have originally been points 13,14,15,16 and 17. This map also shows the relative position of vegetation and other features with respect to the course. Distances are not measured and asterisks do not represent individual trees rather a general depiction of vegetation. The density of vegetation is also relative and not absolute.

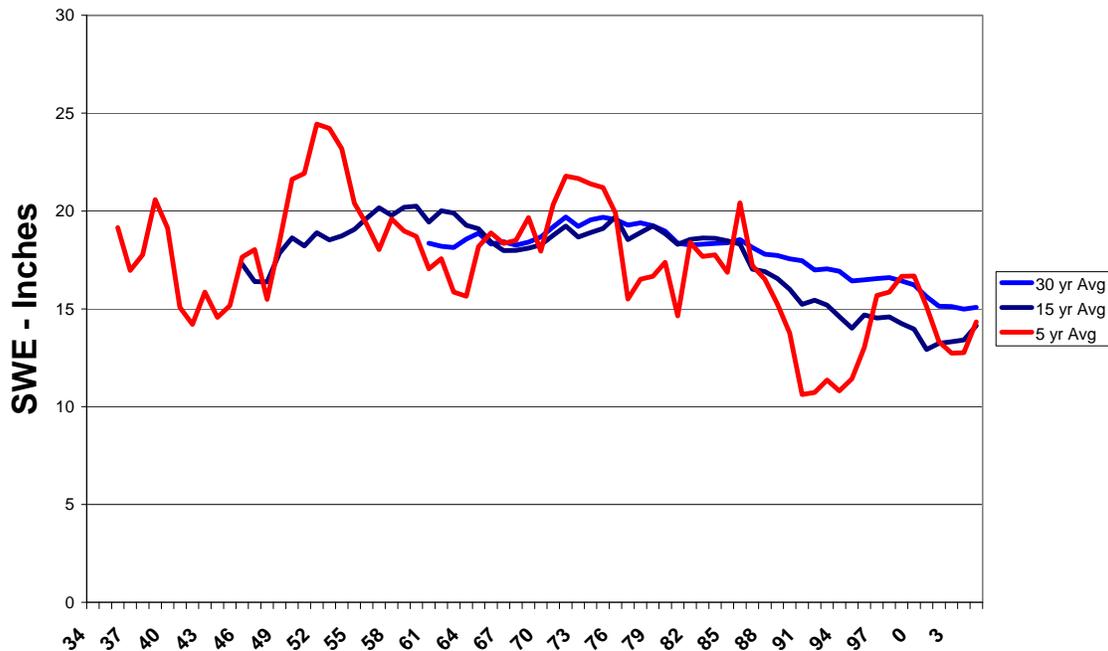
Garden City Summit

In this chart there is clear evidence that this site has been getting less snow over time, from a 30 yr avg high of nearly 20 inches of April 1 swe in the mid 70's to nearly 15 inches in later years. The decline has been relatively steady since the early 50's on all traces: 5, 15 and 30 year running averages. Given the extent and type of vegetation change as well as the magnitude of decline (25%) - most if not all of this decline could be attributed to these site changes. There have always been some trees near this site, in the early days, primarily aspens which have subsequently been almost completely replaced by dense conifer cover. A decline of 25% is pretty much in line with other research and observations. This site should not be used in long term comparisons without data adjustment to compensate for vegetation and other potential changes. In about 2000, a few trees were removed from the west end (sample #4 and 5) of the course to limit the direct impact of interception as well as melt ring influence to the course.

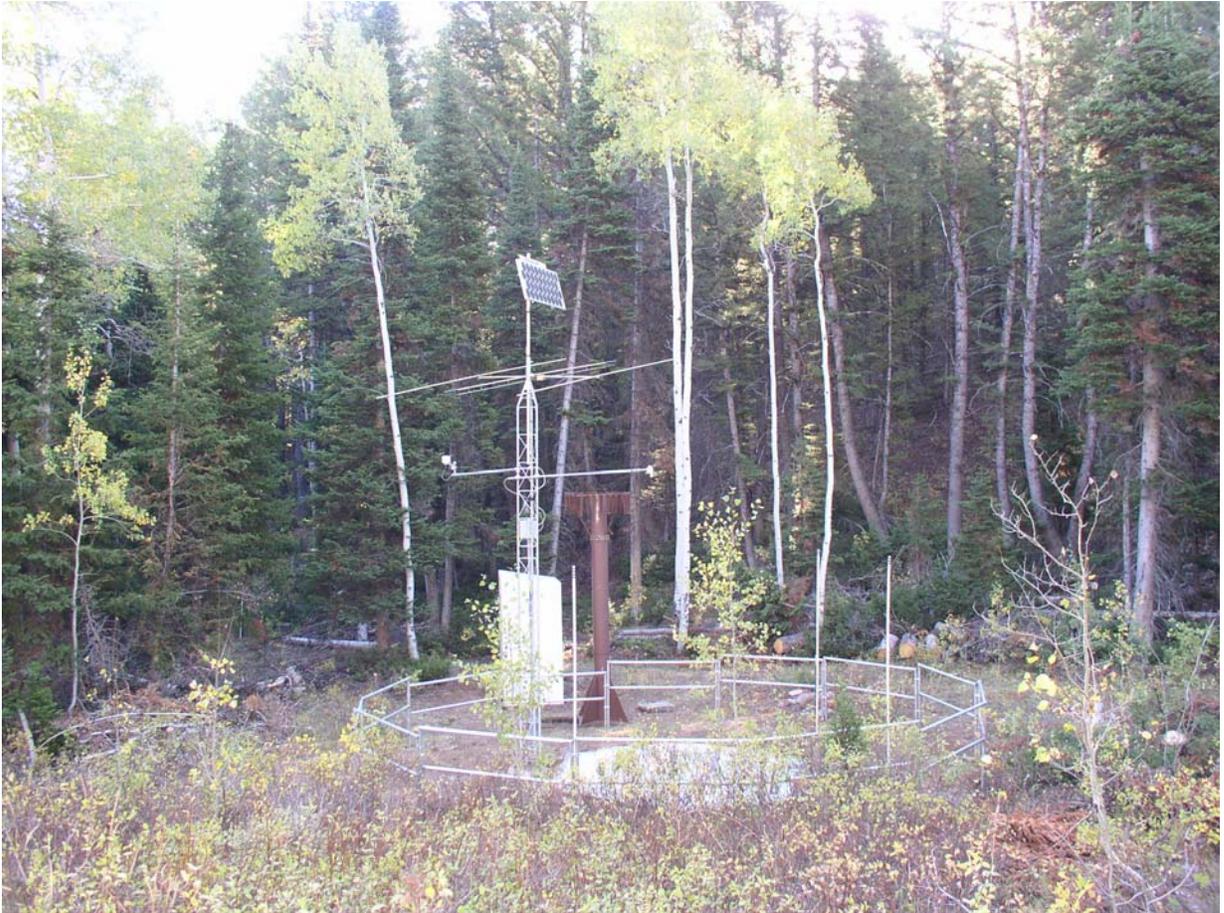
A SNOTEL site was added in the summer of 2009 near the west and north end of the course near sample #5. The area selected is mostly open (cleared for installation) with a few aspens nearby.

On the march 1, 2010 snow survey, transects perpendicular to the snow course were measured to determine the impact that vegetation encroachment has had on the long term average at this site.

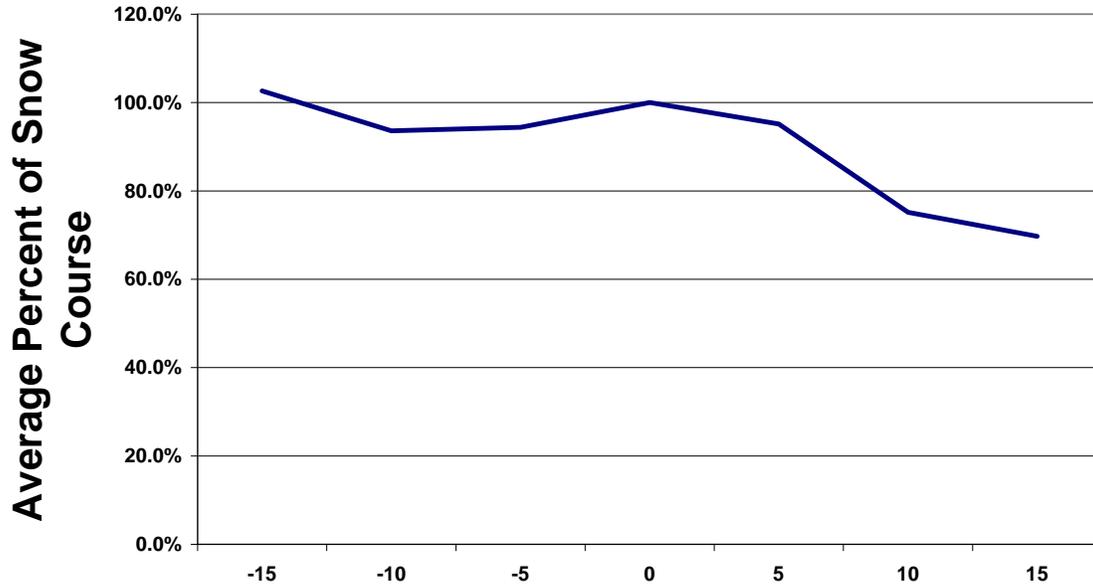
Garden City Summit Snow Course - March 2010

The zero point is the snow course measurement. At both plus and minus 5 feet from the course, there is a decline of about 5% to 7%. The range of the plus and minus 5 foot from the snowcourse is -35% to +33% indicating some real problems at specific sample locations on this course. On the heavily timbered side of the course at plus 10 feet, the decline is about 25% and about 8% on the less vegetated side. (note, trees were removed from this side of the course in early 2000.) The difference between the new snotel site and the existing snow course is dramatic.

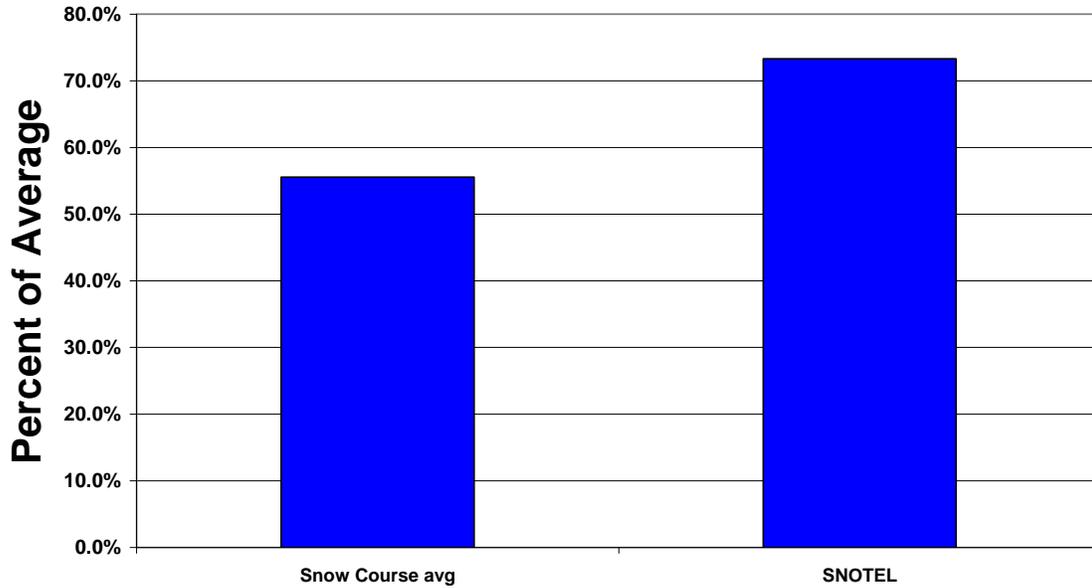
Garden City Summit Snow Course to SNOTEL · March 2010

There is about 20 to 25% more snow accumulating at the snotel site compared to the long term average of the snow course – directly in line with the observed loss of snow at the snow course suggesting that changes in vegetation have been mostly responsible for the observed decline in snowpack at this location.
