### Widtsoe #3

At Widtsoe #3 SNOTEL, there has been some influence of snow creep causing an overweigh on the old snow pillows (and I mean old, steel pillows, these are original hysel pillows at this site - maybe the last in the system) when you have very high snowpacks. The pillows were stable at most snow levels but in 2005, had a significant overweigh, about 20% to 30%. The slope on which the site had been installed was higher than the standard 10% or less recommended. As per other sites where creep has been observed, we have modified the site.

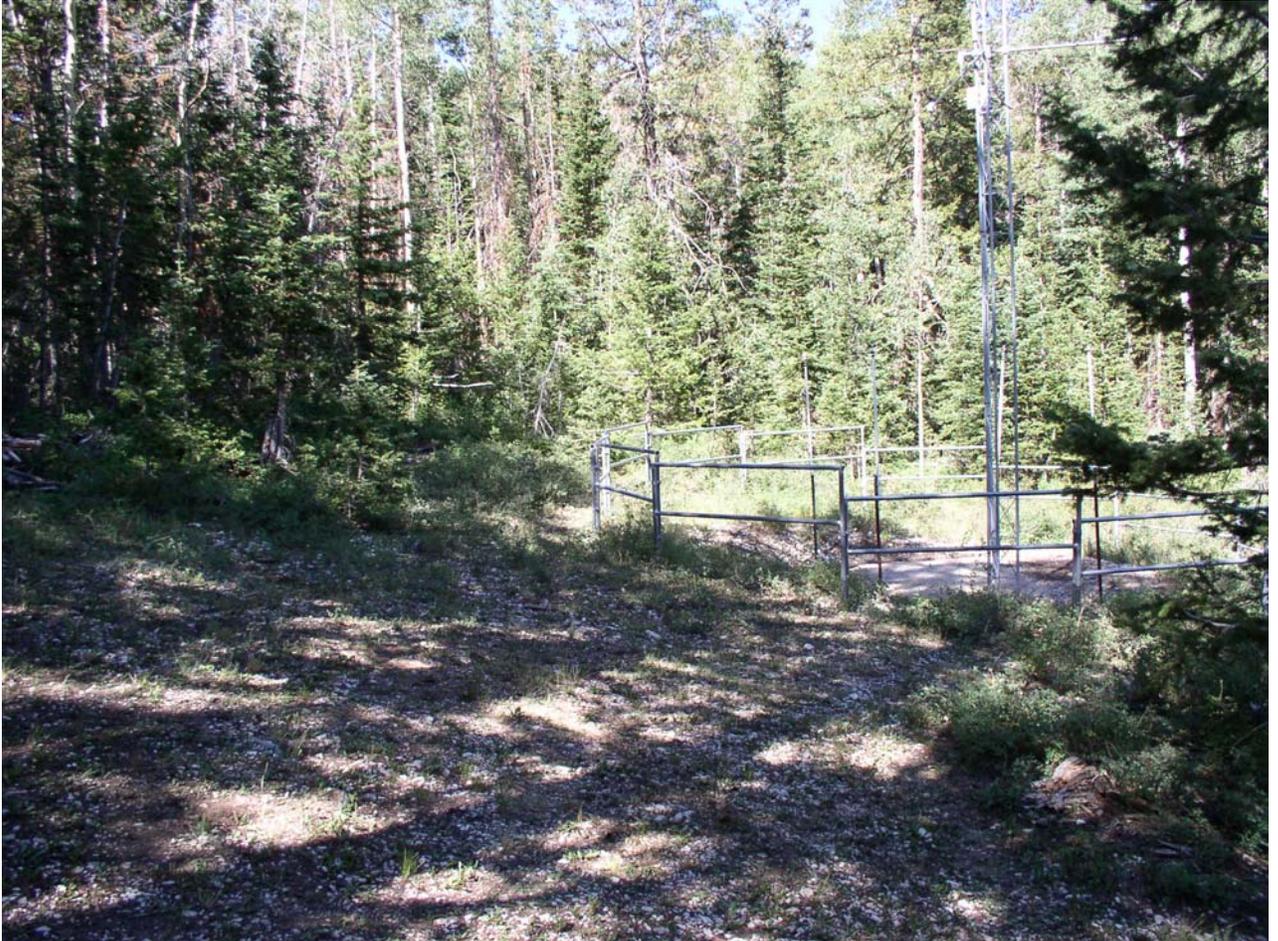
Original installation, note the steel pillows (2) in the center with about a 2 foot flat area on the margins, drainage ditch and then a steep cut slope followed by the original slope. The bottom of the pillow set is where the slope gets steep quickly as you can see by the steps in the fence.

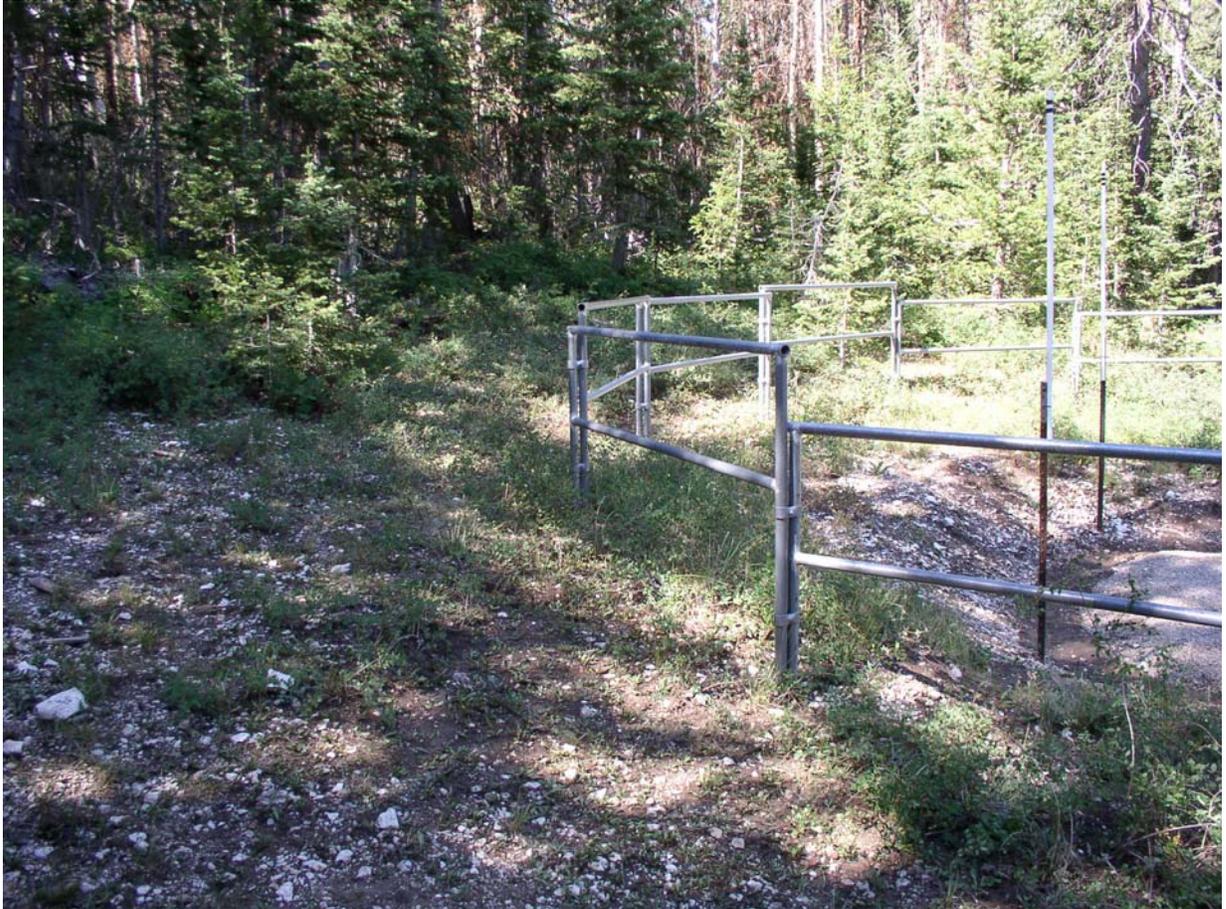
Closer view of the slope and pillows.

We removed the upper fence panels and brought in a small track hoe, took all the material on the upper slope and moved it in 2 directions: 1 - made the pillow pad on the down hill direction about 4 feet larger, right next to the sectional steel fence and 2- placed a berm on the uphill side to act as a key or a dam in the snowpack to anchor it in place.

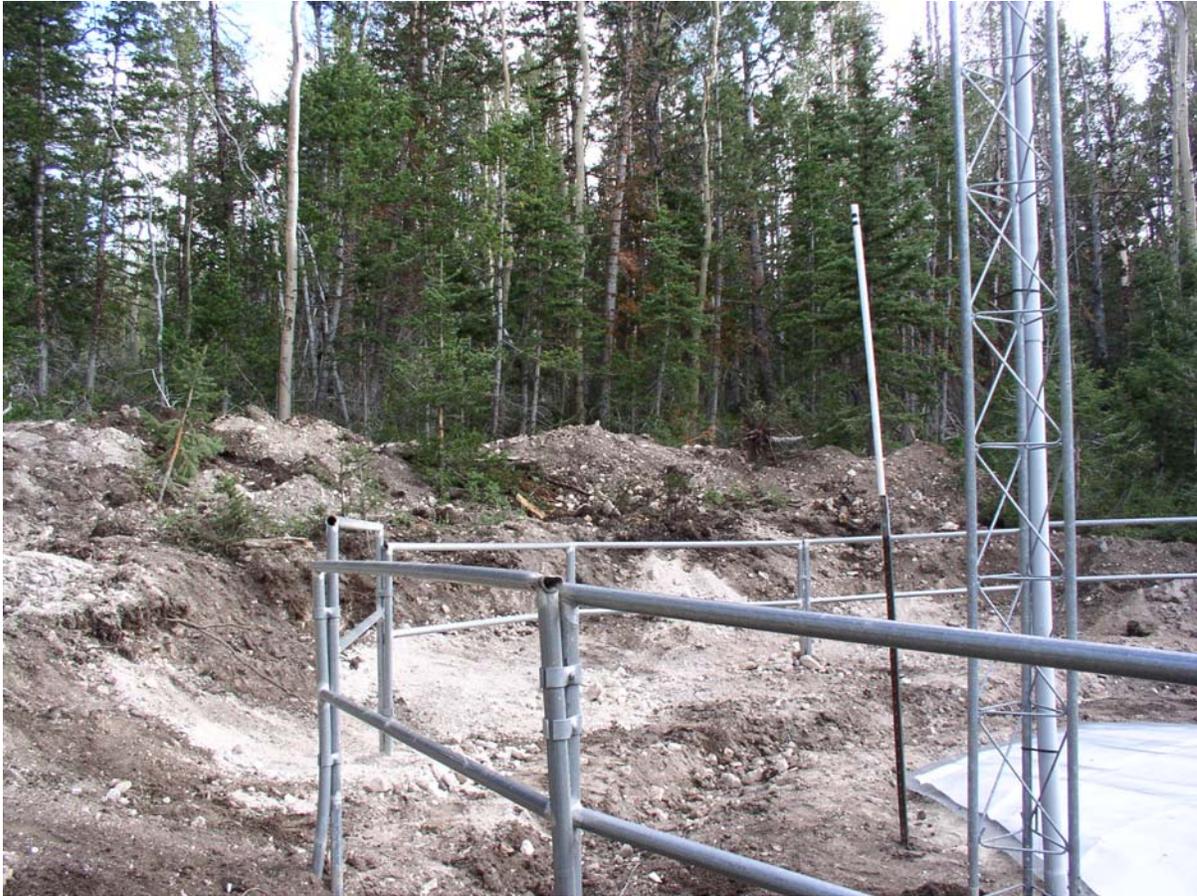
We excavated about 10 feet and placed what did not go to the bottom as the berm on the top which is about 2 feet high in most places. So now we have the berm on top, then about a 3 to 4 foot segment of original slope, then the cut bank and then 10 or more feet of flat area to finally get to the edge of the pillow. The pillow remains on the original surface it was prior to the site modification. We then re-installed the fence and as you can see, it is pretty level around the top portion of the pillow pad. The fence is now actually in limestone bedrock.

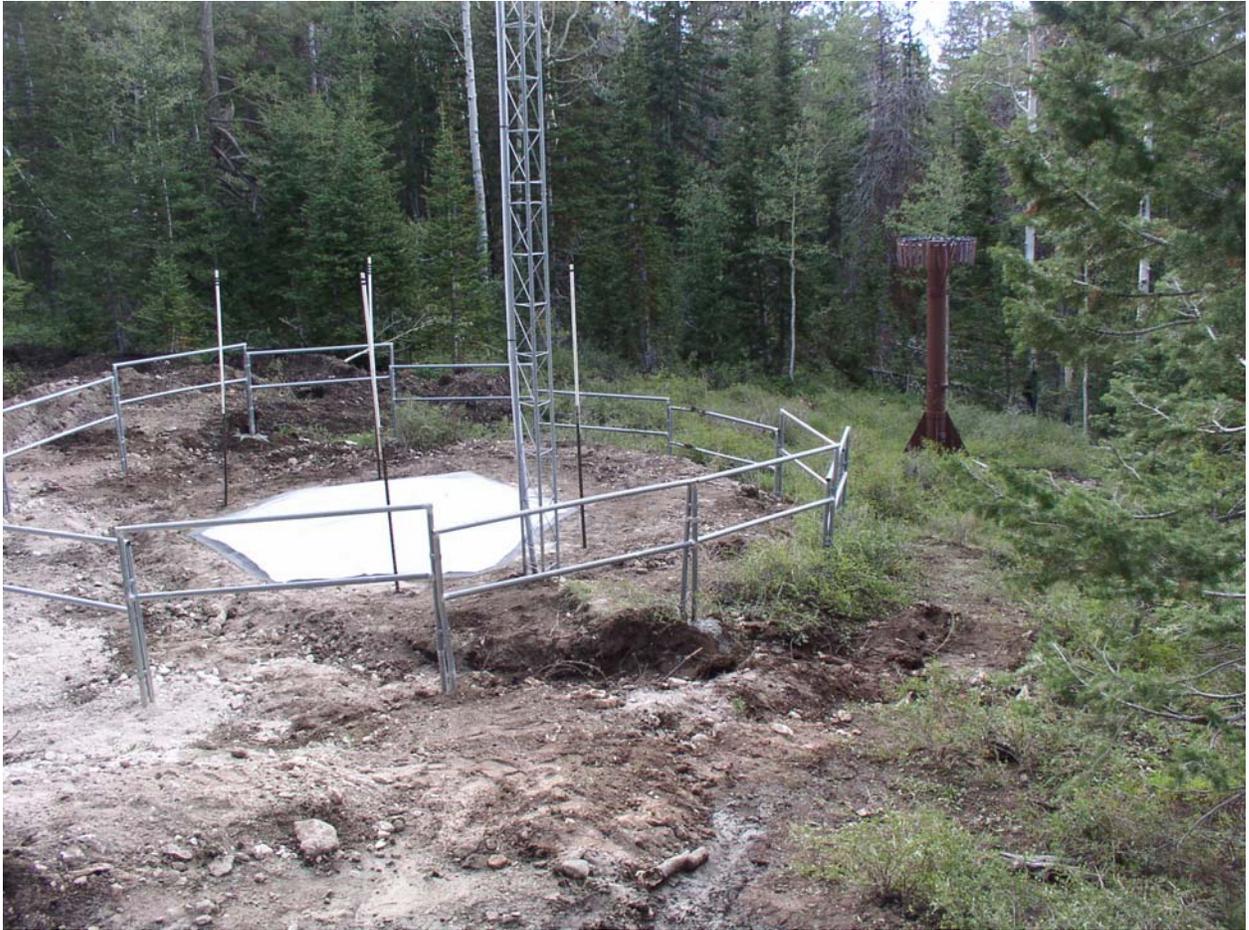
From this vantage point you can see the extension on the bottom as well as on the top and after a little raking and smoothing, it looks pretty good. The bottom extension is necessary to help prevent the snowpack below the site from pulling pressure onto the pillow and on the top side, to prevent gravity creep onto the pillow. Notice the bottom fence section to get a good idea just how steep this slope was, the pillow had 59 inches of head in the shelter which was just to the right of the precip can. The bottom of each fence section is 24 inches off the ground and level. We now have a pillow pad that is nearly 30 feet of level ground from edge to edge. We don't expect to see dramatic changes in accumulation due to this modification as the vegetation around the meadow opening was not altered. We may see a change because we replaced the steel pillows with hypalon although it does have a white cover. Another thing we will watch closely.

We did this site mod: excavation, fence removal and re-installation, pillow replacement, shelter replacement, re-plumb all lines, etc in one long day.
